Bio-Stimulated Surface Healing of Historical and Compatible Conservation Mortars

Snežana Vučetić, Damir Čjepa, Bojan Miljević, John Milan van der Bergh, Olja Šovljanski, Ana Tomić, Emilija Nikolić, Siniša Markov, Helena Hiršenberger and Jonjaua Ranogajec

<https://doi.org/10.3390/ma16020642>

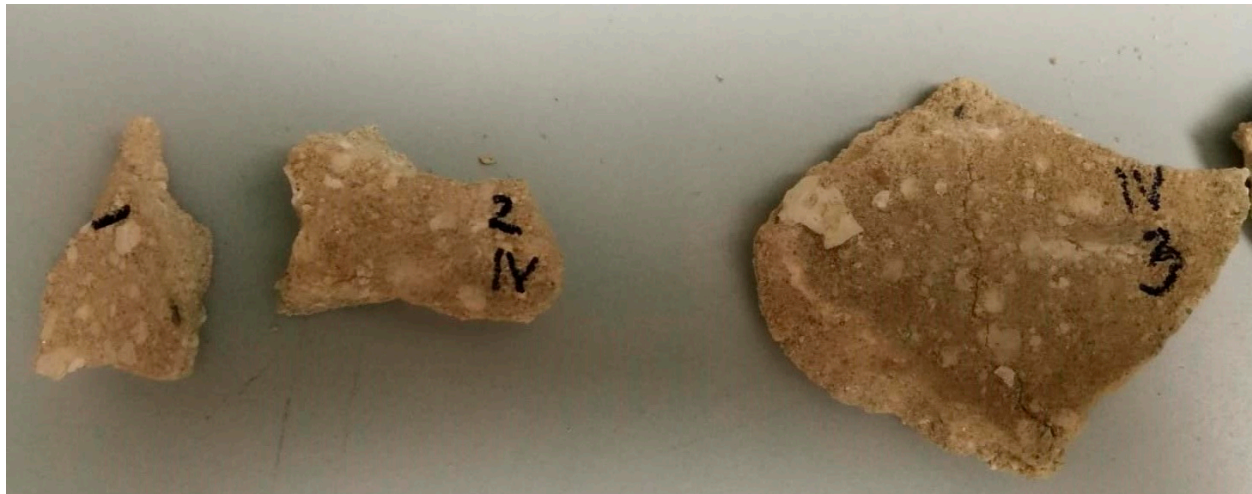
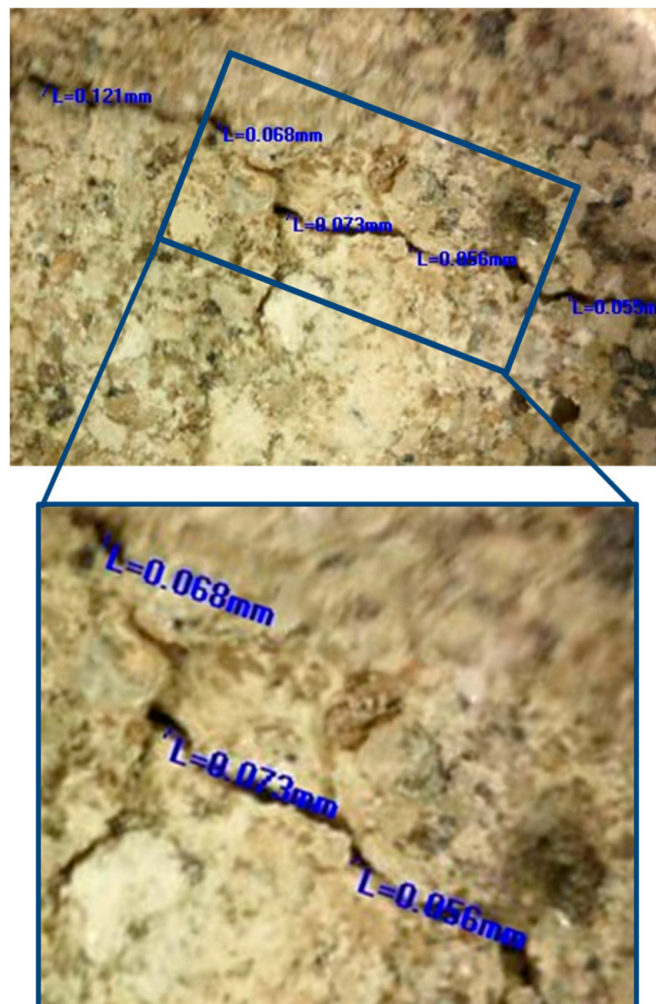
Figure 1. Original mortar: (a) photo of the sampled materials; (b) example of microscopic images of the cracks in original walls (measured crack width: 0.121 mm; 0.068 mm; 0.073 mm; 0.056 mm; 0.059 mm; average 0.075 mm).

More than 30 small samples (approximately several cm in diameter) with irregular shapes and a diversity of surface cracks with varieties in their width were sampled, as shown in Figure 1a. These samples were the materials that the conservators decided to remove prior to the conservation works because they were in a very bad condition (some parts of the walls were still covered with this mortar). In order to have as realistic as possible of an approach for the bio-stimulated healing experiment, the samples were grouped based on their crack widths. The samples which were too small or unusable for the crack-healing investigation were used for other laboratory investigations. Laboratory characterisation of the historical mortar samples was performed using sieving and chemical analysis, stereo-optic microscopy, X-ray fluorescence (XRF), X-ray diffraction (XRD) and scanning electron microscopy (SEM) coupled with energy-dispersive spectroscopy (EDS). Sieving and chemical analysis (acid dissolution) of the historical samples were conducted in accordance with RILEM recommendations in order to determine the aggregate and binder ratio [6]. The basic morphological features of the historical samples were determined by optical microscopy (OMANO OMXTL/V7 Articulated Boom Microscope, Microscope LLC, Roanoke, VA, USA). The mineralogical composition of the powdered samples after sieving analysis (binder (fraction < 63 μm), agglomerated binder/lumps (fraction > 710 μm) and aggregate (710–63 μm)) was determined by XRD analysis with a PHILIPS PW 1050 Diffractometer (Philips, Netherlands) with a Cu-K α radiation source. The elemental analysis (XRF) was performed directly on the samples' surfaces without any preparation. These measurements were performed with a BRUKER μXRF ARTAX 200 system (Bruker Nano GmbH, Berlin, Germany) using a Rh radiation source, 25 kV and 1.5 mA under a He atmosphere. SEM measurements were performed after 28 days of incubation using a JSM-5500LV (JEOL, Tokyo, Japan) device and after 150 days of incubation using a JSM-6460LV (JEOL, Tokyo, Japan) device. None of the examined samples were previously sputter-coated with gold.

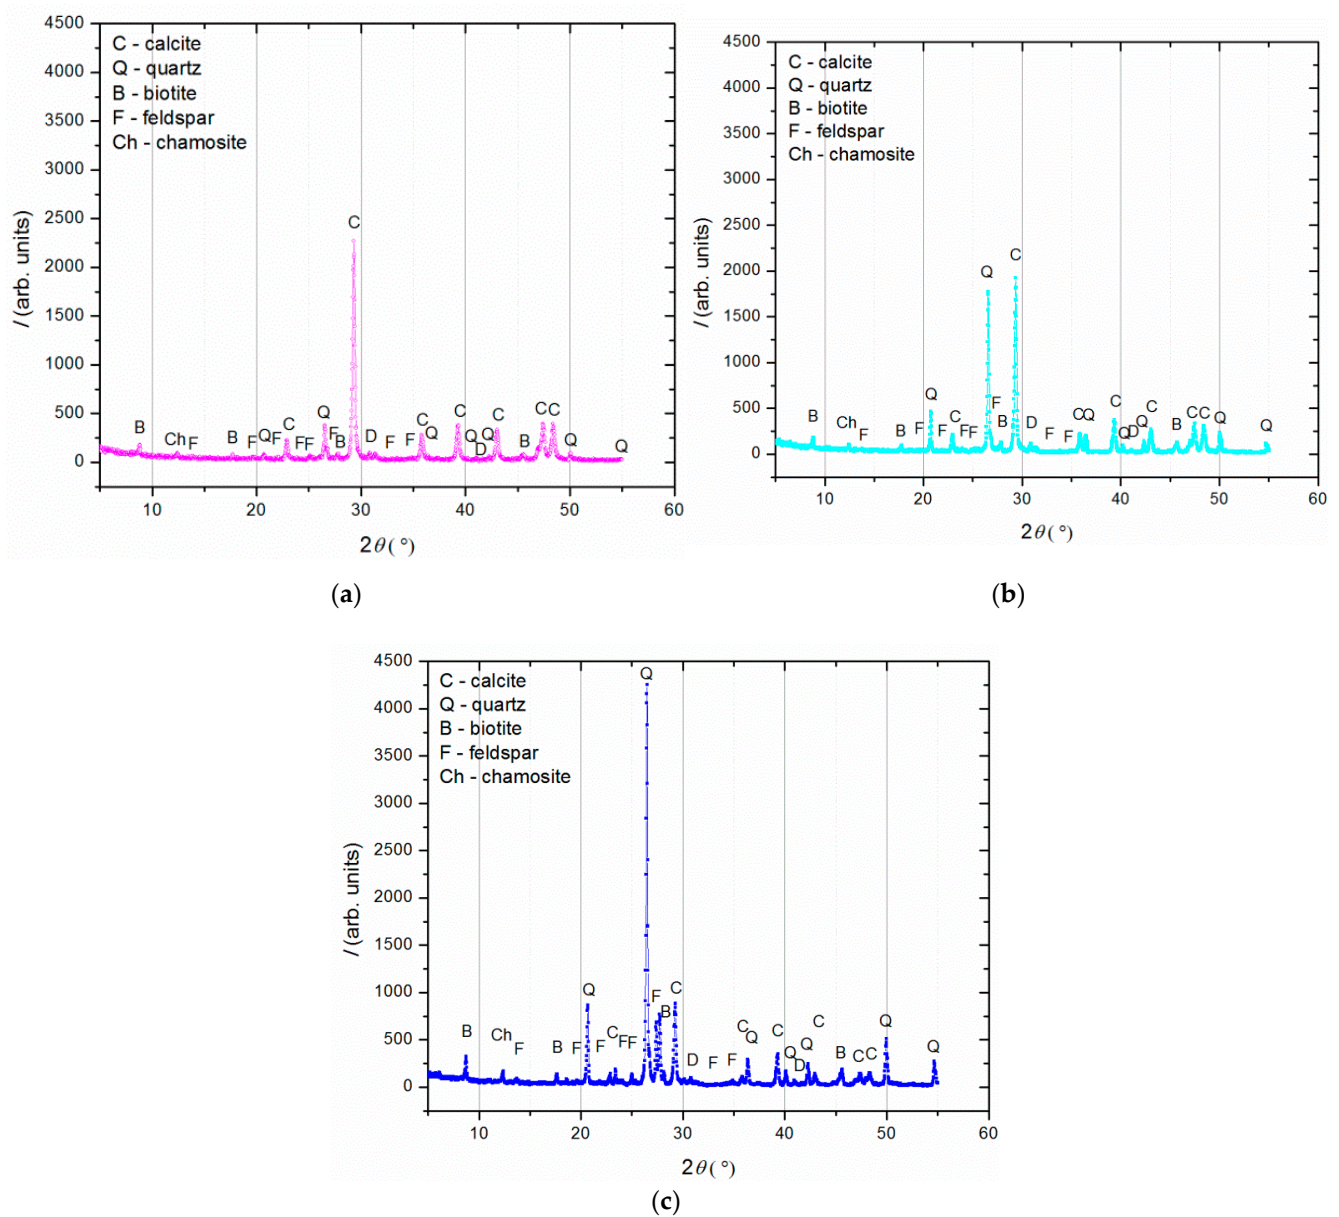
**Figure 4.** XRD analysis of (a) binder (fraction < 63 μm); (b) agglomerated binder/lumps (fraction > 710 μm); (c) aggregate (710–63 μm).

XRD analysis (Figure 4) was performed on three separated fractions: (a) binder, <63 µm, (b) agglomerated binder, >710 µm and (c) aggregate, 63–710 µm. In the case of the examined fractions, the following mineral crystalline phases were detected: calcite [CaCO₃], quartz [SiO₂], biotite [(K(Mg,Fe)₃(AlSi₃O₁₀)(F,OH)₂], feldspar [KAlSi₃O₈-NaAlSi₃O₈-CaAl₂Si₂O₈] and chamosite [(Fe₂,Mg)₅Al(AlSi₃O₁₀)]. In the case of the binder fraction (<63 µm), as expected, a significantly higher proportion of calcium carbonate (calcite) was identified, while in the case of the aggregate fraction (710–63 µm), a dominant presence of quartz was found. The identified calcite in the aggregate fraction was a consequence of limestone being used for the historical mortar preparation. The identified biotite was more significant in the case of the aggregate in relation to the binder fraction, which was expected since this mineral is usually present in river sands. Additionally, the slightly higher intensity of the identified chamosite in the aggregate relative to the binder fraction was a consequence of the already-identified particles of the crushed bricks. Finally, in the agglomerated binder/lumps (fraction >710 µm), the dominant mineral form, namely calcite, corresponded well to the composition of the binder fraction (<63 µm) except for the presence of quartz, which was intercalated in the agglomerated binder/lumps.

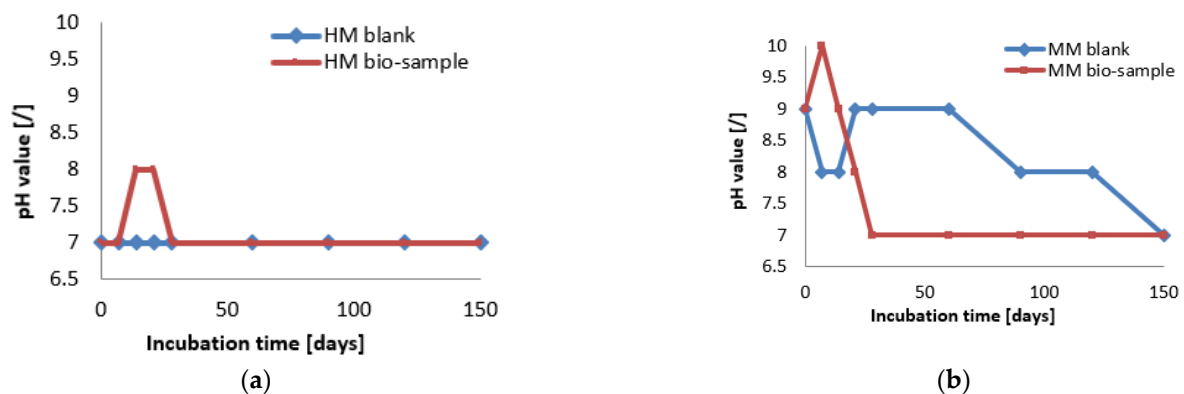
Figure 7. The pH monitoring of HM samples (a) and MM samples (b) [6].

In the case of the MM samples, the pH value change in the bio-samples followed a trend similar to the bacterial viability, as shown in Figure 7. After a short decreasing period at the start, the pH value reached the initial level, and this value was maintained until 60 days of incubation. Due to a decrease in number of vegetative cells, pH value of the MM bio-sample also decreased until the end of incubation, reaching a final value of 7, as shown in Figure 7b. The HM blank sample remained stable during the incubation period, while the MM blank sample was affected by the continuous hydration process and had steep changes as well as a lower final pH value compared to the initial value.

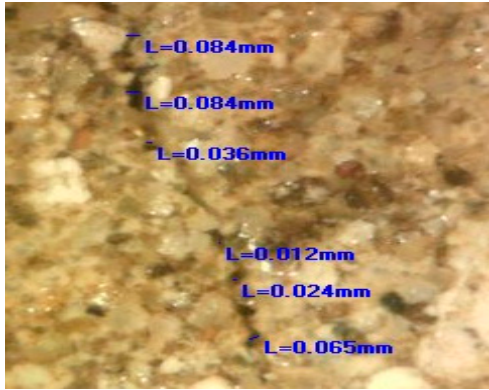
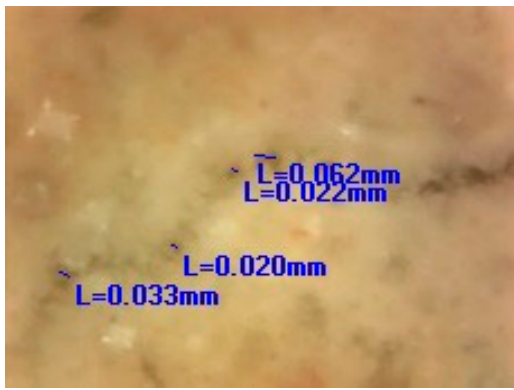
150 days HM sample		150 days MM sample

Sample	HM Bio-Samples		MM Bio-Samples	
0 days, crack width, mm	Measured	0.045; 0.67; 0.045; 0.115; 0.090; 0.067	Measured	0.070; 0.094; 0.071; 0.098; 0.091; 0.085;
	Average	0.0715	Average	0.084
150 days, crack width, mm	Measured	0.084; 0.084; 0.036; 0.012; 0.024; 0.065	Measured	0.033; 0.020; 0.022; 0.062;
	Average	0.051	Average	0.034
Magnified detail of the measurement position

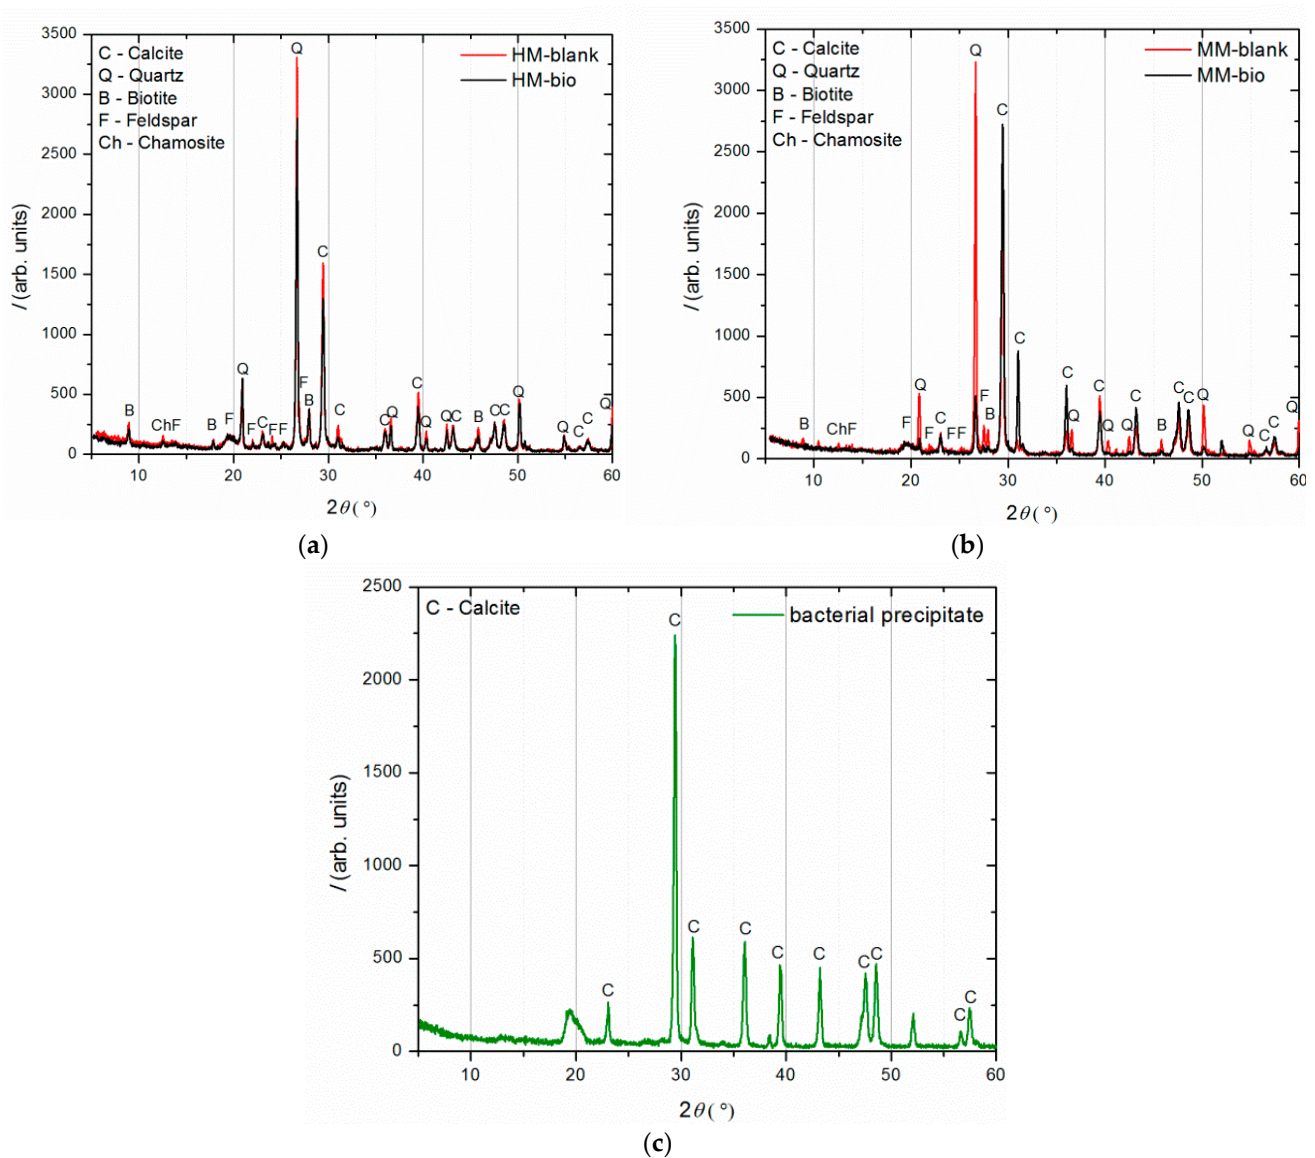
Figure 11. XRD analysis after 150 days of incubation: (a) HM blank and HM bio-samples comparative results, (b) MM blank and MM bio-samples comparative results, (c) sole bacterial precipitate.

Comparing the XRD patterns of HM blank and HM bio-samples (Figure 11a), there were no significant differences except for the intensity of all the diffraction peaks being reduced for the HM bio-sample. In contrary to this, comparing the MM blank and MM bio-samples (Figure 11b), the MM blank sample had a much higher quartz maxima than the MM bio-sample, while the MM bio-sample had a much more intense calcite maxima in comparison to the MM blank sample. This implied that strong calcite precipitation occurred in the MM bio-samples, in the region of the crack-healing area.

The comparison of the obtained results between the HM bio- and MM bio-samples confirmed that the bacteria-induced precipitation was limited in the HM samples because of the lack of free calcium ions. Namely, the “young” mortars with incomplete carbonation, as it was the case with the MM bio-samples, which were exposed to wet conditions, had a suitable quantity of free calcium ions inside ready for the healing processes [24]. The XRD analysis of the sole bacterial precipitate showed the presence of pure calcite, which confirmed that the increase in the calcite content in the healed MM bio-sample was a consequence of the bacterial activity. The unassigned peaks in Figure 11c belonged to the
