Fragments of Wall Painting from Residential Buildings at the Site of Čair (*Viminacium*)

ARCHAEOLOGIA BULGARICA
XXV, 1 (2021), 15-25

Dragana GAVRILOVIĆ / Bebina MILOVANOVIĆ

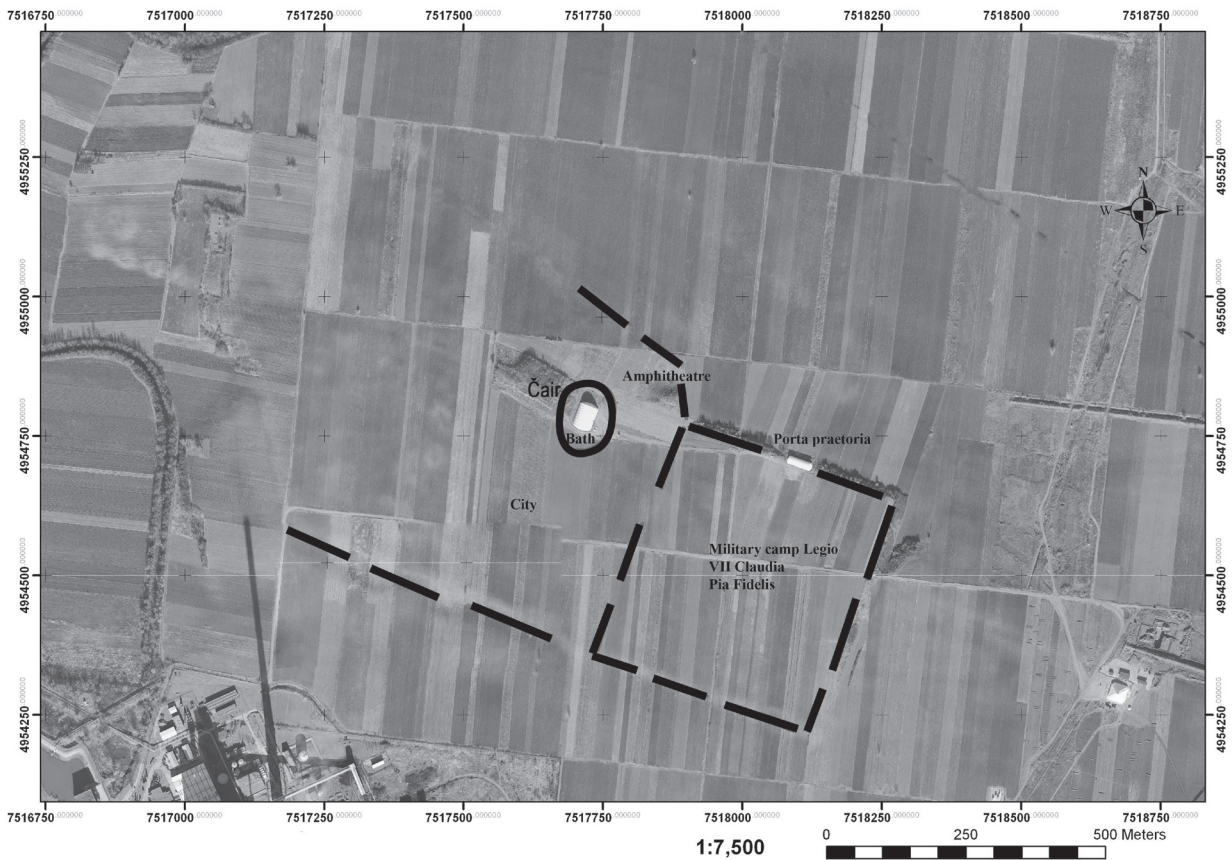
Fig. 1. Aerial photo of *Viminacium* showing the city and the *castrum* (photograph from the documentation of the Institute of Archaeology, Belgrade)

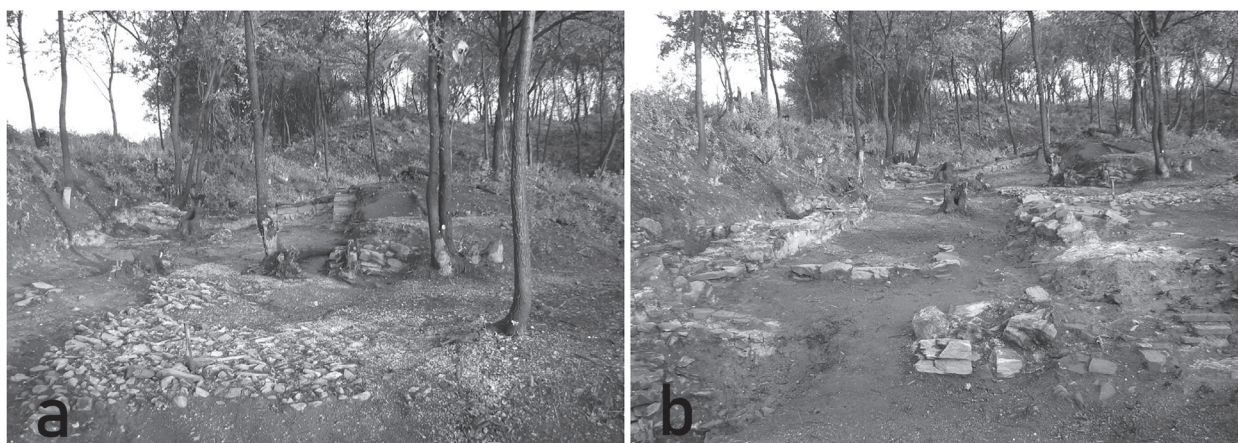
Fig. 3. Re-excavations at the site of Čair from 2007 (photograph from documentation of the Institute of Archaeology, Belgrade)

The re-excavations at the site of Čair were carried out in 2007, after which the western part of the area was excavated and partly researched by M. Vasić around the beginning of the 20th century (**fig. 3a, b**). The condition of the site required clearing of vegetation and wood, as well as careful removal of tree stumps, which significantly slowed down the works and damaged the buildings to a certain degree. A grid with square fields was laid, as shown in old Vasić's map, with the dimensions of each square being 5x5 m. A total of twelve squares were researched (I-VI and XV-XX; **fig. 2**). The first set of squares encompassed the southeastern part of the previously excavated area with a smaller Roman well built of limestone rock, visible on the surface of the terrain. As the excavations progressed, the walls and floors discovered earlier quickly became visible.

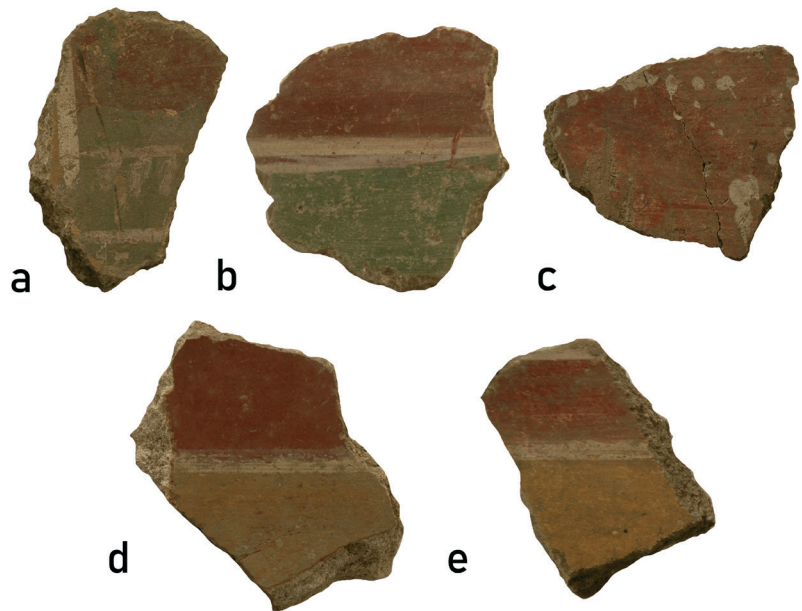
Fig. 4. Fragments of wall paintings, *Viminacium*, Čair (photos by the authors)

Fig. 4a. This fragment has several colored sections. It can be noticed that first it was painted with ochre, then red paint. The red zone has traces of the ochre underpainting only in the part in which these two overlap. After that, it was painted green, with a thick coat of paint. There is a white vertical line on the left side and the green surface is decorated with two horizontal pinkish-white lines. There are three diagonal strokes on the upper line. The position of the fragments can be determined by the drop of green paint on the red surface (the

upper left part of the fragment). The plaster was smoothed, but not polished.

Fig. 4b. The plaster surface has red underpaint, with green paint over it. On the border of these two colors two horizontal white lines merge into one. Horizontal traces of brush are visible on the plaster. The plaster of the intonaco is smoothed, but not polished.

Fig. 4c. The light red surface was decorated by sprinkling white paint, which represents an inept imitation of porphyry (Faedo 2000, 63). Imitation of marble revetment was the most common in the First

Pompeian style, where a variety of colors non-existent in natural stone were used. This type of decoration was not abandoned in the ensuing styles, nor in the painting of the Late Antiquity period, where it appears in the socle zone (Ling 1992, 13; Rogić 2018, 172-173).

Fig. 4d. Two fragments have identical decoration, although they were rendered using different painting techniques. On the fragment shown in **fig. 4d**, the entire surface was covered with a red underpaint and polished, then ochre was applied, and the white line painted in the end. In the case of the fragment in **fig. 4e**, there is no red underpainting; the red zone was painted first, followed by the ochre, and lastly the white line (the paint was not polished). The fragment used to belong to a jamb, head or another opening in the wall; from the other side of the corner it spreads on top of the red surface.

The fragment in **fig. 4d** stands out by its reddish intonachino³ about 1 mm thick. The intonaco is white, about 2 mm thick, while the arriccio is grey. Total plaster thickness is approximately 3 cm.

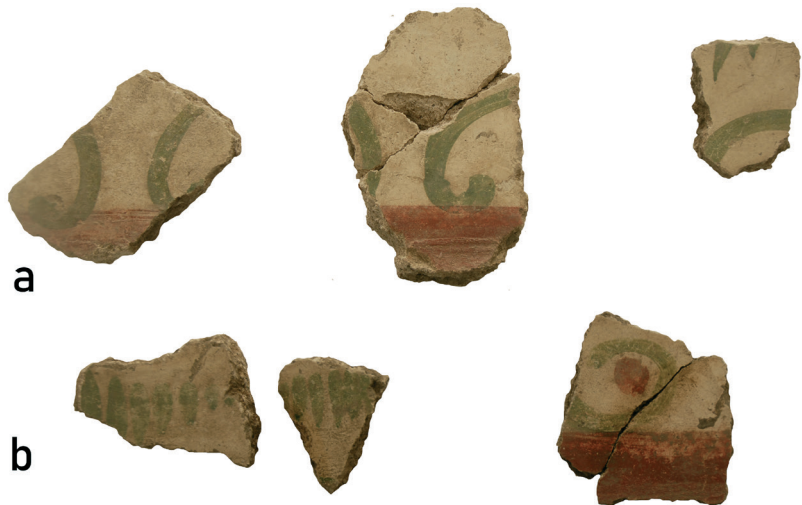
Fig. 5. Fragments of wall paintings, *Viminacium*, Čair (photos by the authors)

According to the painted content and the plaster features, fragments in **fig. 5a** and **fig. 5b** belong to the same wall painting, but cannot be combined into a larger unit. Green volute motifs painted next to the red border can be seen in **fig. 5a**. Among the fragments which could be classified as belonging to this group, there are also

ones with white plaster surfaces and a red border, which extend to the white mortar surface. In **fig. 5b**, on the left, there are two fragments with decoration in the form of short strokes made with a brush with a rounded tip. The strokes are painted from bigger to the smaller ones. On the third fragment, a part of a motif resembles the one from **fig. 5a**, but it positioned differently and has a red dot in the middle of the volute.

The groups of fragments in **figs. 5a, 5b, 6** have the same features of plaster, which is 1.5-3 cm thick. The intonaco is white, 1-3 mm thick, grey arriccio is about 1.5 cm thick, while the levelling coat is white, with a high concentration of lime, and it is friable, with visible traces of straw in the plaster.

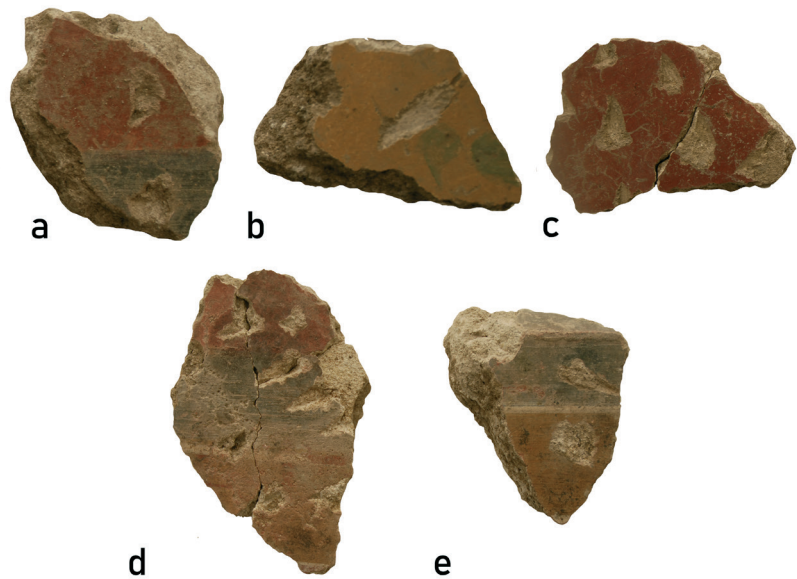
Fig. 7. Fragments of wall paintings, *Viminacium*, Ćair (photos by the authors)

Fig. 7a. shows a very thin coat of red paint that extends to the edge of a dark blue surface. Traces of the brush on intonaco are visible, suggesting that the painting was made on fresh plaster (fresco technique). The painted coat was damaged by pecking (Ling 1992, 198-199; Salvadori et al. 2015, 24)².

In **fig. 7b** there is an ochre surface with green plant motifs; the painted coat is very thin. Plaster surface is damaged by pecking.

A polished red surface, damaged by pecking, is shown in **fig. 7c**.

Fig. 7d – the entire surface is underpainted red, which extends to a dark blue area and an ochre strip. White lines are painted on the edges of the ochre strip. The plaster surface was pecked.

Fig. 7e. The fragment which used to belong to a jamb, door head or another opening. On one side of the angle, the fragment has a well-polished red underpaint covered with a blue border which continues to the ochre surface. Blue and ochre are separated with a white line. On the other side, only blue is visible, without the red underpaint. The entire plaster surface is pecked.

Evidently, in many fragments, the surface is damaged from pecking with a sharp tool. The deepest notch is 6mm deep. For the most part, the plaster of the pecked surfaces shows the same features, it is preserved in two or three coats, except in the cases listed further in the text (**figs. 4d, 5a, 5b, 6, 7e**). Plaster thickness ranges from 3 to 5 cm. White, 2-4 mm thick intonaco can be seen (a mixture of slaked lime and marble-dust). Arriccio is grey (a mixture of slaked lime and sand), 1.5-3 cm thick, with fine gravel visible in some of the fragments. The coat for wall levelling is not the same in all fragments; in some cases, it is somewhat lighter than the arriccio.

The red intonachino identified in the fragment in **fig. 7e** differs from the other fragments damaged by pecking. It has four coats, which is a rarity when it comes to the preserved wall paintings from Viminacium (normally, a smaller number of plaster coats are preserved). The plaster is about 5 cm thick. Intonachino is reddish and about 1mm thick, intonaco is white, 3 mm thick, arriccio is grey (4

cm), and the rest belongs to the first coat of plaster (levelling plaster), which has the same colour as the arriccio.

in the past, as shown in **fig. 7a-e**, but also in some examples from the Thermae and the Amphitheater in *Viminacium*.

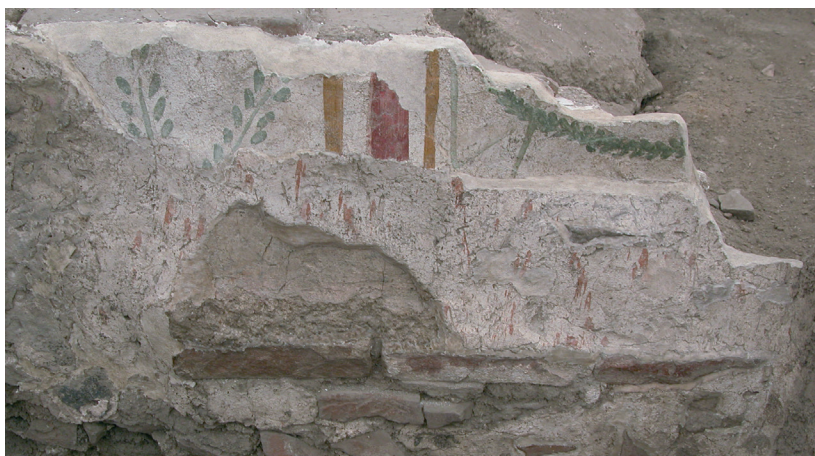
Fig. 8. *Viminacium, thermae*, wall paintings (photo by the authors)

In the Thermae, two layers were identified in the preserved *in situ* paintings, one on top of the other, i.e., in one moment in the past, a new painting was made over the previous one – **fig. 8** (Rogić 2018a, 899). The earlier painting has a marble motif and was decorated by sprinkling red paint onto the white plaster surface. The painting of the later period contains green branch and garland motifs, and between these two motifs, there are two vertical ochre strips, with a somewhat wider red strip between them. Fragments of wall painting with highly polished painted plaster surfaces were also found at the site.

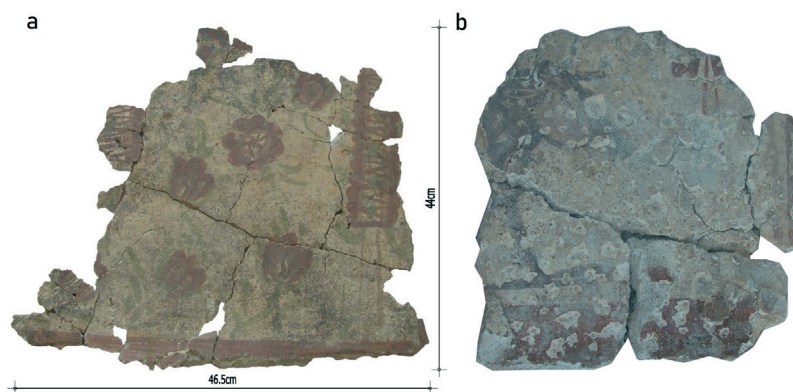
Fig. 9. *Viminacium*, amphitheatre, wall painting (after Rogić 2014, Abb. 2)

For examples of renovation in the amphitheater on the fresco from the earlier phase, see the zoomorphic motif in **fig. 9b**, and the floral motif in the fresco from the later phase (**fig. 9a**). These two frescos were separated by a conservation procedure (Rogić 2014, 508).
