INTERIORS OF NEOLITHIC HOUSES AT DRENOVAC

This paper presents new results on the research of Late Neolithic houses at the site of Drenovac near Paraćin, central Serbia. We discuss remains of five houses with different degrees of preservation, which directly influenced obtained data and possibilities for interpretation. The extensive excavations enabled the investigation of two houses in their entirety that offered valuable information about the internal organization of space, installations and movable finds. One of the most important results was the identification of two-story structures.

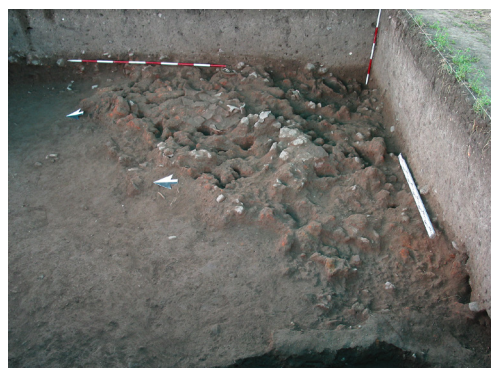
Figure 4. The excavated part of house 1, trench XV.

House 1 is the first Neolithic house investigated during our renewed excavations at Drenovac. Trench XV encompassed its southwest part, which can be clearly seen on the geomagnetic map (Perić et al. 2016, fig. 5). A part of the house interior with destruction layer and ceramic vessels was investigated (fig. 4).

In house 1, 27 vessels were found in a small excavated section of the house, but it was impossible to discern any pattern of spatial distribution (fig. 4).

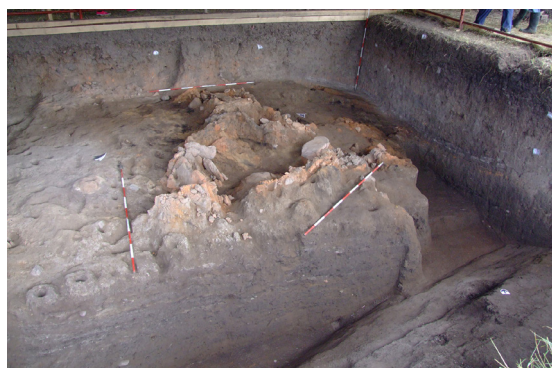
Figure 5. The excavated part of house 2, trench XVI.

House 2 was investigated in trench XVI. Its eastern half was excavated, with a partly preserved long southeast wall, but the major portion of the house had been destroyed by later pits. Interestingly, this house partly lay above a ditch from an earlier period. Ground subsidence of the ditch backfilling caused the eastern section of the house to sink, which can be clearly seen on the north profile of the trench (fig. 5).

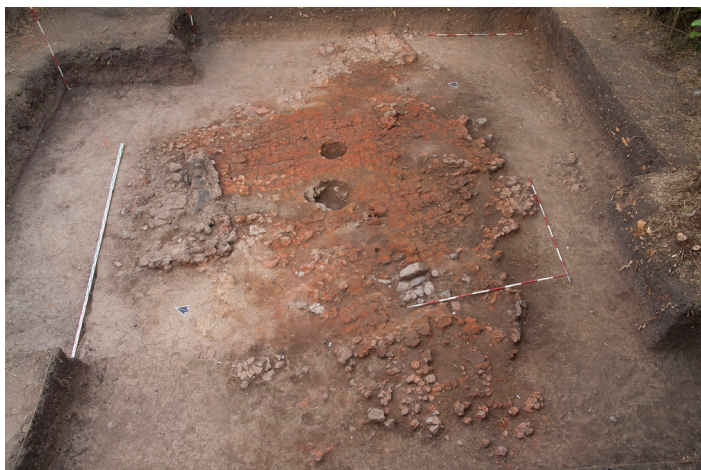
Figure 6. House 3, trench XVII.

House 3 was investigated in trench XVII. The house destruction layer and the floor edges were damaged to the extent that prevents us from determining reliably the outlines of the structures. The preserved part of the floor measures approximately 7 by 5 m (fig. 6).

In house 3, no remains of partition walls were noted. Based on the appearance of the interior and distribution of small finds and their relation to the oven, as the only internal structure in the house, one gets the impression of a small house consisting of a single room (fig. 6).

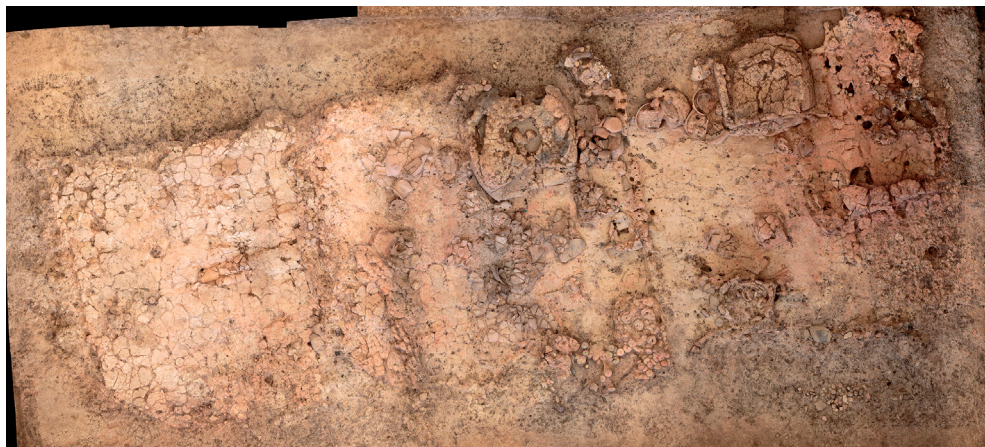
Figure 7. House 4, trench XIX.

House 4, investigated in trench XIX, is the best-preserved house, probably due to a thick colluvium that covered it. The house was a two-story building measuring 12 by 5 m (fig. 7) with exceptionally well-preserved interior that offered unique insights into the Neolithic way of life.

Horizontal division of space could only be clearly determined in house 4. The ground floor was divided into three rooms separated by partition walls. The eastern and central rooms had nearly identical dimensions, while the western room was a bit smaller (figs. 7, 9-11). What the organization of space on the upper floor looked like is still beyond our grasp.

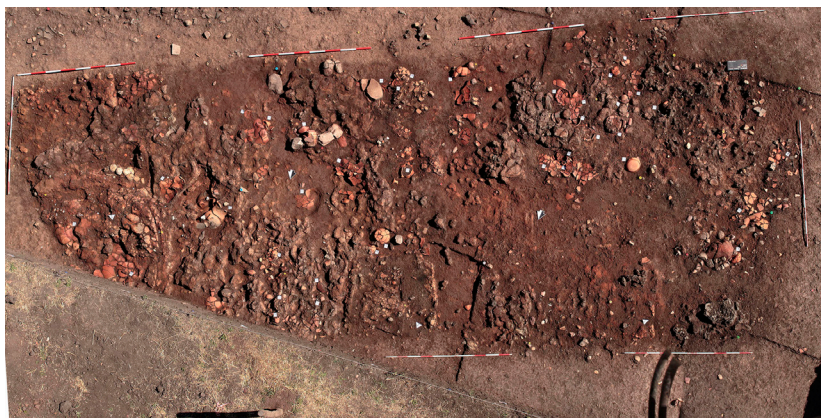
Figure 8. House 5, trench XX.

House 5, investigated in trench XX, about 20 m northeast of trench XIX, was much worse preserved, obviously due to the fact that it had not been covered with a colluvium layer and was found at considerably lower depth than house 4 (fig. 8). The house dimensions were determined based on the destruction layer and the outline of the surface where the traces of burning were recorded. The house was also a two-story building, with the ground floor measuring 12 by 5 m.

In house 5, there was no direct evidence of an internal partition wall, but the existence of two partition walls is assumed based on the arrangement of ovens. Division of space in three rooms is assumed to be similar to that of house 4, having in mind similarities

in house sizes and position of ovens (fig. 8).

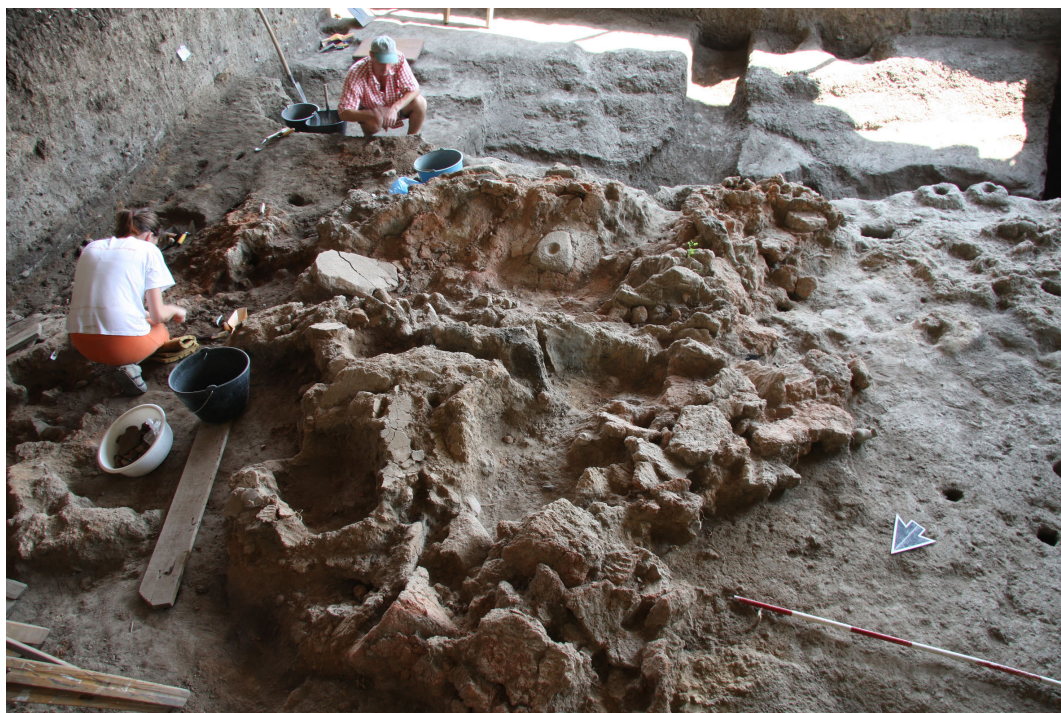
Figure 12. House 2, with remains of a partition wall and an oven. View from the northwest.

In house 2, there are clear indications of a partition wall that may have separated the northeast part from the southwest part of the house, *i.e.* the space with grindstones from the space on its southwest side, which, perhaps due to later pits, was almost void of any small finds (fig. 12).

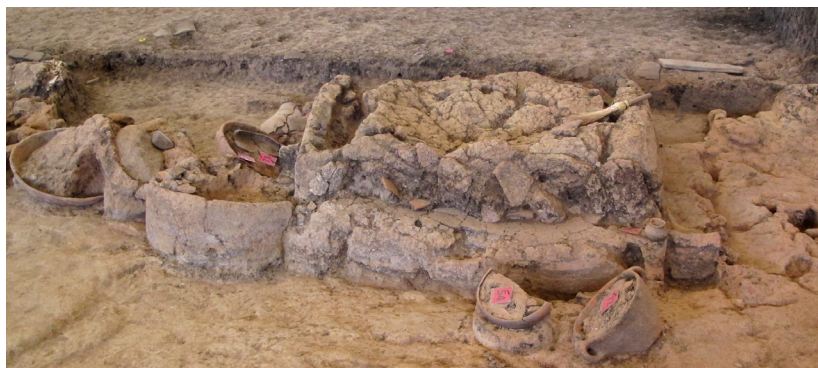
Figure 13.
House 4: an oven
in the eastern
room.

As the best-preserved structure, house 4 offers the greatest number of preserved internal features. Three ovens were noted here: two along the northern wall of the eastern and central rooms and the third on the upper floor (figs. 13–15a-b). There were no internal installations in the western room. Two domed ovens on the ground floor were approximately the same size. They differed from each other as the oven in the eastern room had two fixed clay receptacles: one of irregular circular shape was attached to its southwest corner, and the other was narrow and shallow, placed along the eastern edge of the oven. On the western side of the oven, a grinding stone with a clay receptacle was found. The grinding stone was inside the receptacle but turned upside down. A hand stone was found next to the grinding stone (fig. 13).

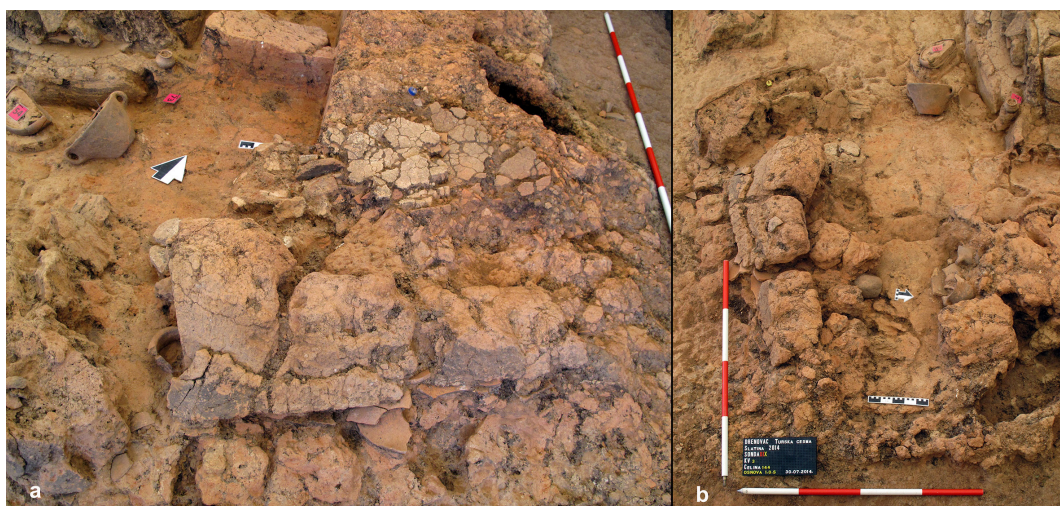
Figure 15a-b. *House 4: remains of the oven in the eastern room that collapsed from the upper floor.*

The third oven was on the upper floor above the eastern room and since it had collapsed and consequently suffered extensive damage, its shape or dimensions could hardly be reliably determined. Nevertheless, judging from the preserved parts, it probably had approximately the same dimensions as the ovens on the ground floor (fig. 15a-b).

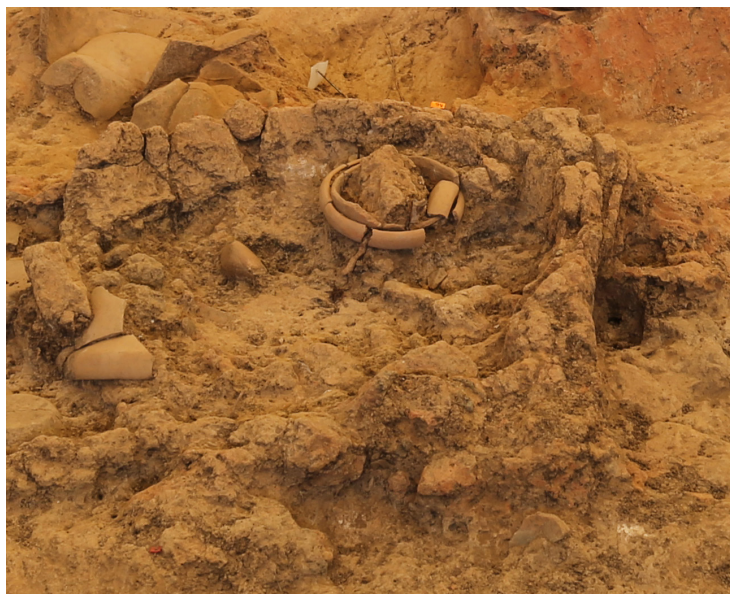
Figure 16. House 4: clay bin with pottery vessels in the central room.

Along the south wall of the eastern room, there was a clay container with two ceramic vessels stacked in one another. It may have been used for storing pottery designed for specific content or purpose (fig. 16).

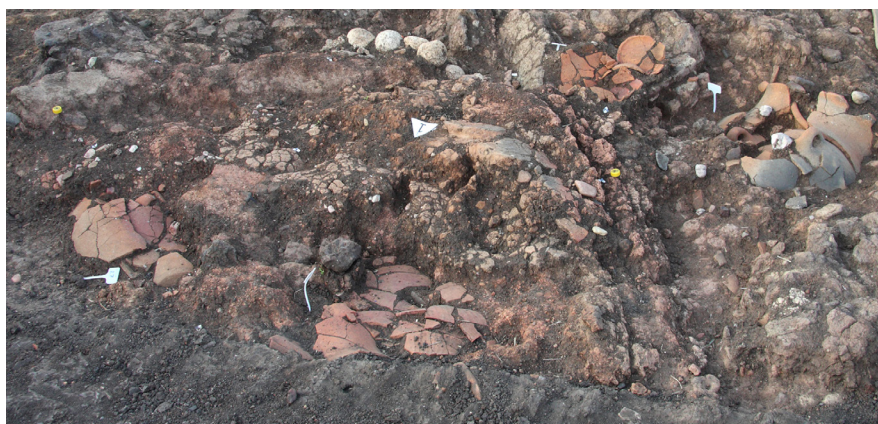
Figure 21. House 5: oven 1.

House 5 was considerably less preserved than house 4. With no direct evidence of the partition walls it is difficult to define the spatial affiliation of internal structures. The remains of four ovens were noted in the house – three on the ground floor and one on the upper floor (fig. 17). Judging by the arrangement of ovens on the ground floor, we assume that this house had three rooms with one oven in each room. The ovens in the western and central room were found along the northern wall (figs. 18 and 19). In the eastern part, the remains of two ovens were noted, one of them along the southern wall (fig. 20), and the other one almost in the central part of the room (fig. 21). As at least four fragmented

pithoi (fig. 22a-b) were noted below the remains of the oven in the central part (fig. 21), it was concluded that this oven must have stood on the upper floor but collapsed on the pithoi when the house was burnt.

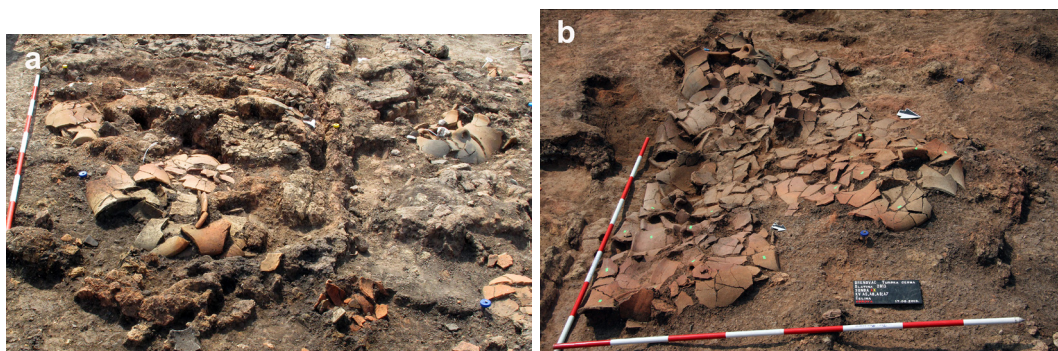
Figure 22a-b. House 5: pithoi under oven 1.

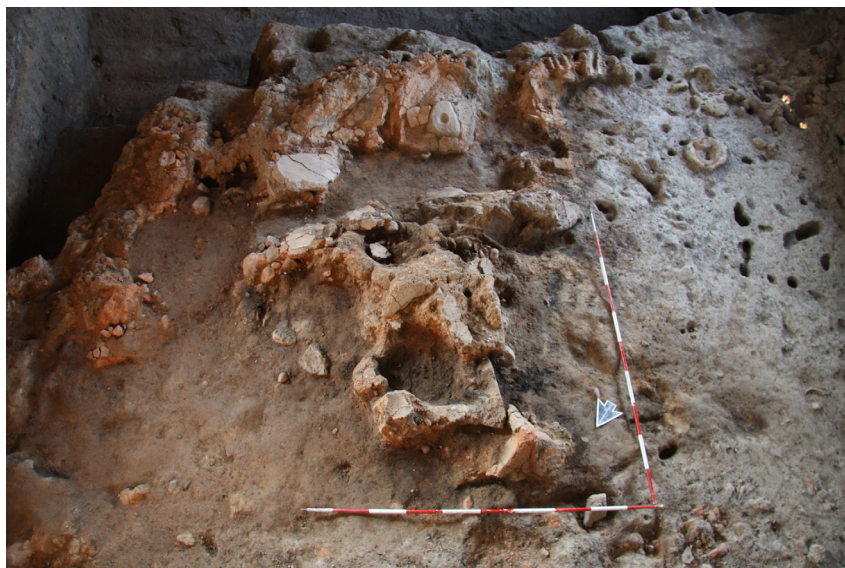
Figure 23. House 2: remains of an oven.

In house 2, the remains of only one oven were found. Since they were displaced by later digging to a considerable extent, it was not possible to determine its shape or dimensions. The remains of the oven were located in the northwest half of the room (fig. 23).

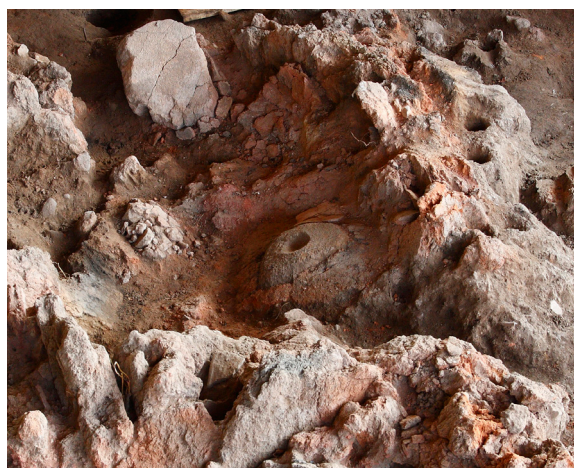
Figure 26. House 2: central grindstone that cracked due to the high temperature.

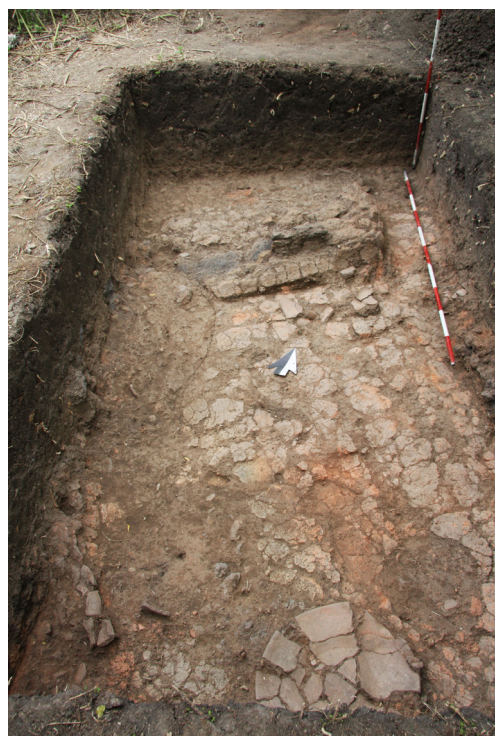
Figure 27. House 3: remains of an oven.

In house 3, one fairly badly damaged oven was found, with only external walls preserved, but without floor or dome (figs. 6 and 27). The preserved parts of the oven display a remarkable similarity to the remains of the ovens in the eastern room of house 4, which we have already noted stood on the upper floor (fig. 15a-b). As the remains of the oven were located in the northern section of the structure, it is likely that the oven had leaned against the northern wall of the house (fig. 6). With this part of the house badly damaged, it is difficult to presume specific activities taking place around the oven. However, as this was most probably a single-room house, and taking into consideration the small finds, this oven seems to have served both for heating and food preparation.
