ARCHAEOLOGY AND SCIENCE

19
2023

DRAGANA GAVRILOVIĆ

OVERVIEW OF CONSERVATION AND RESTORATION APPROACHES TO THE PROTECTION AND PRESENTATION OF VIMINACIUM WALL PAINTINGS

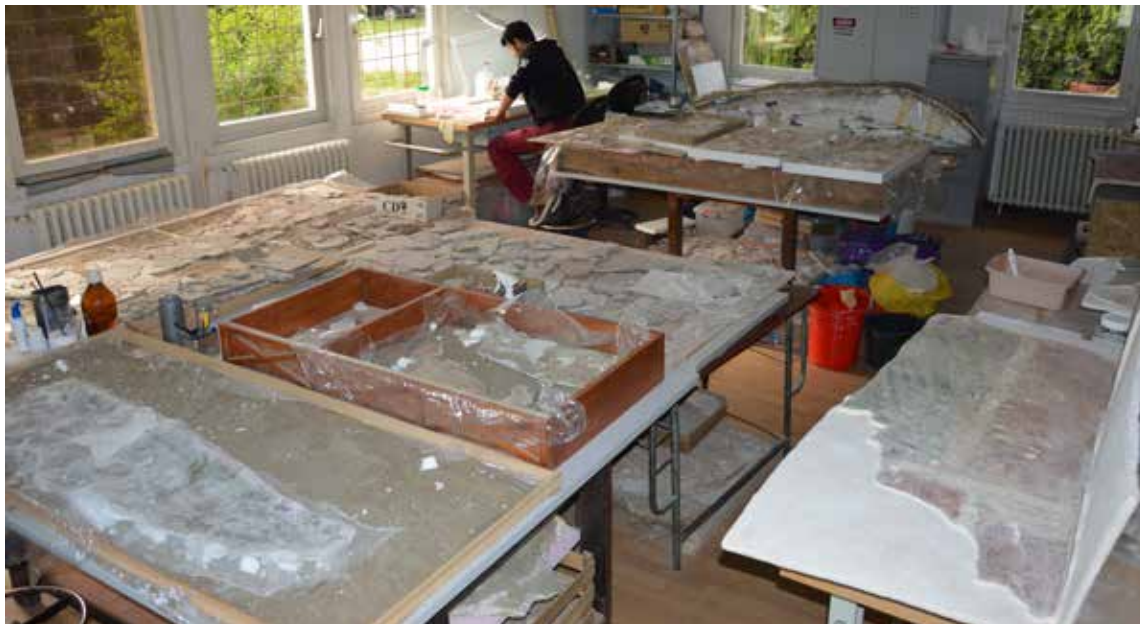
Figure 2. Studio for conservation and restoration in Viminacium (photo by the author).

In the studio for the conservation of wall paintings at the archaeological site of Viminacium (Figure 2), different methods are applied. Fragmented wall paintings, are given special attention during conservation in Viminacium, and their hypothetical reconstructions with the aim of their comprehension are executed to allow scientific interpretation of the iconography and presentation.

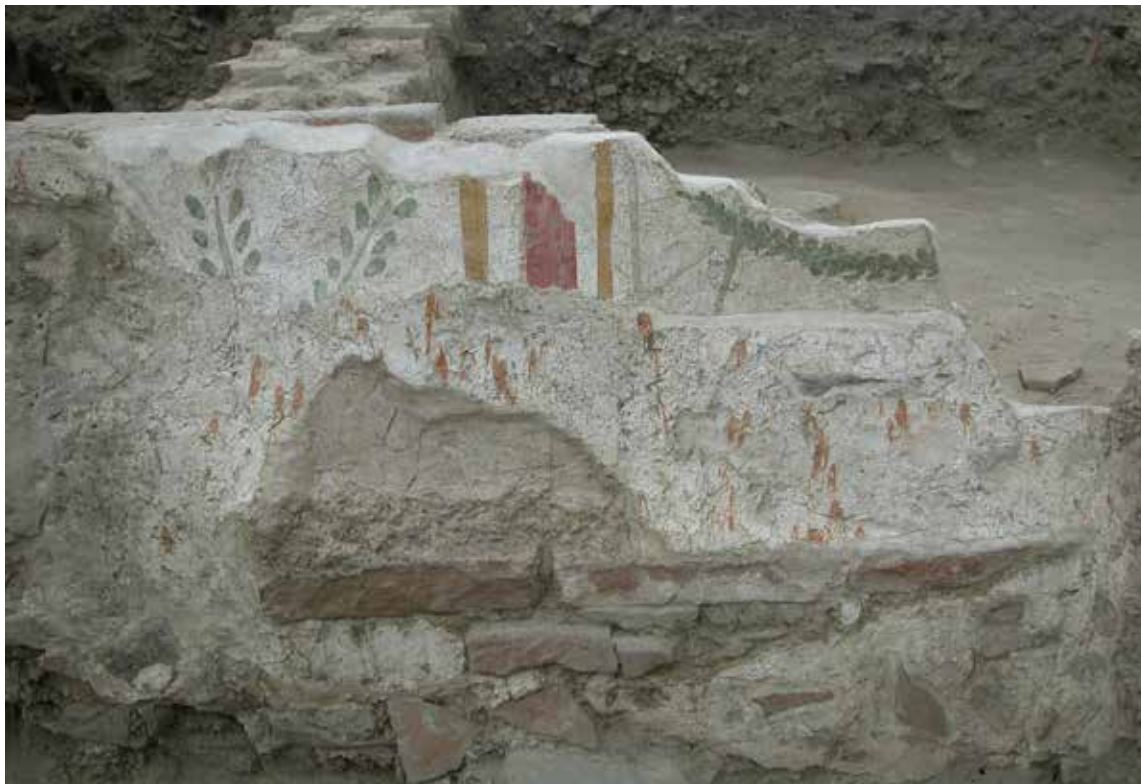
Figure 3. City baths – thermae, room 4, wall painting *in situ* (photographic documentation of the Institute of Archaeology).

Two layers of wall painting were found, one over the other. The painting from the earlier phase contains an imitation of marble panelling, while the painting from the later phase has a floral decoration, as well as border strips (Gavrilović and Milovanović 2021: 22; Рогич 2014a: 162–163). During the conservation of this painting in 2008, only the edging repair was done, which is a common conservation procedure, when the weakened edges of the wall painting are strengthened with plaster. The paint layer was stable and there was no need for any other interventions. The entire process of conservation was carried out by experts from the Institute of Archaeology.

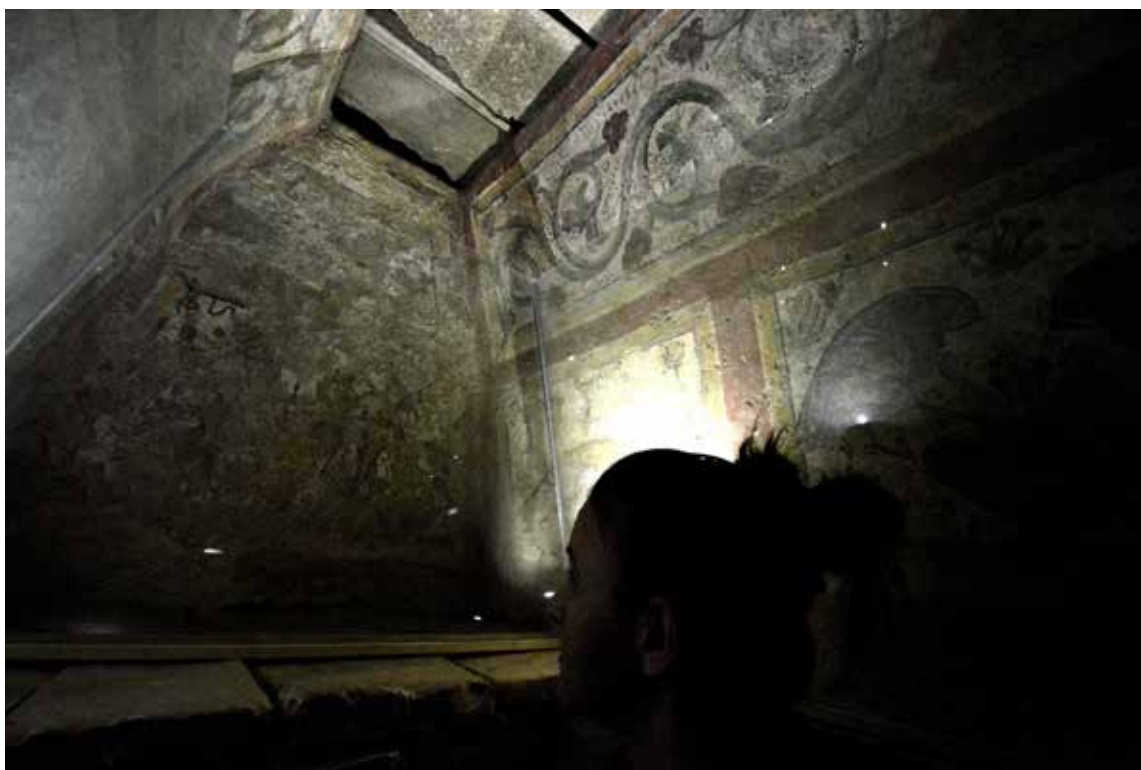
Figure 4. Grave G-160, wall painting *in situ* (photographic documentation of the Institute of Archaeology).

Tomb with Cupids. The Tomb with Cupids (G-160) is dated to the very beginning of the 4th century (Korać 2007: 125–140; Anđelković Grašar, Nikolić and Rogić 2013: 73–100; Рогич 2014a: 210–222). The painting was preserved and presented *in situ*, at the Pirivoj site (where it was found during archaeological excavations in 2003), within the visitor space under the protective structure (**Figure 4**).

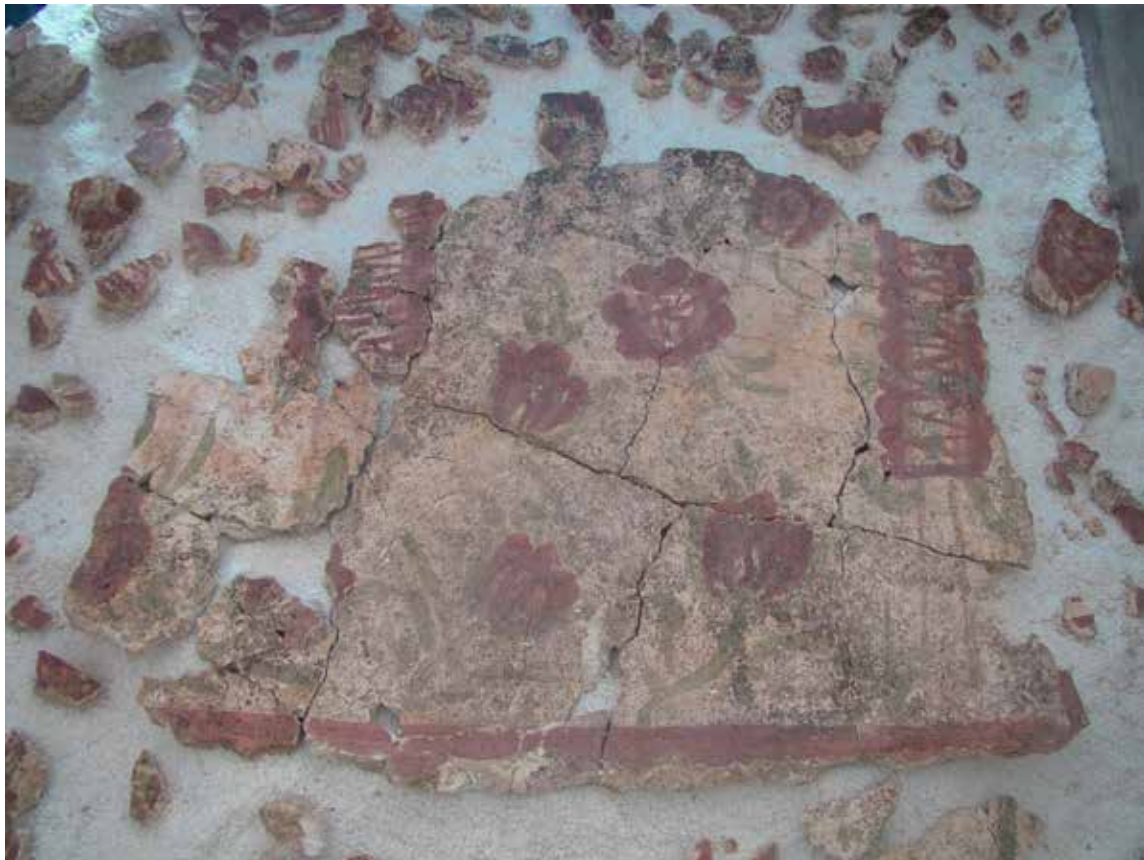
Figure 5a. Construction 1 - Merging fragments of the wall painting from the later phase (photo by the author).

Fragments from the later phase were joined back together (**Figure 5a**) and the resulting unit was transferred to a new support. A completely reversible conservation procedure was then carried out. The original plaster was not levelled, but with the help of 3D scanning, a composite support was created that follows all the unevenness of the original plaster (Rogić 2017: 153–154) (**Figure 5b**). The basic idea was to preserve the back of this plaster, and for this reason, glue was applied only to those parts where there was no original plaster.

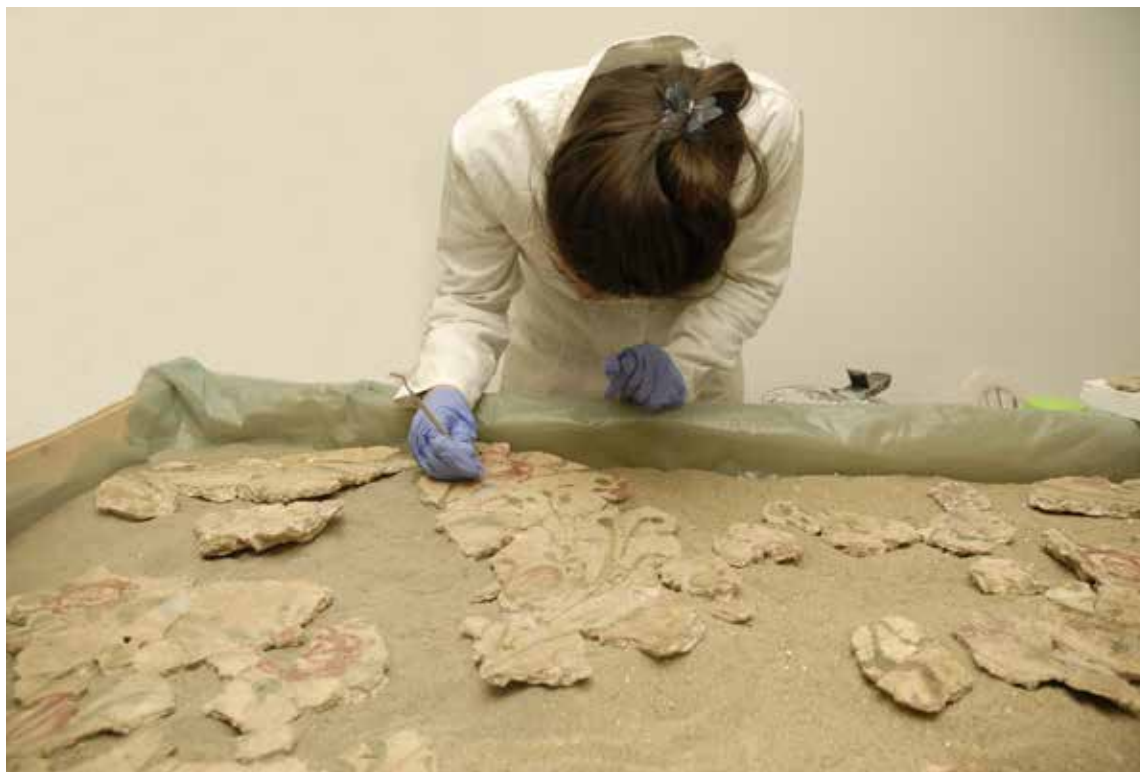
Figure 6a. Construction 2 - Merging fragments of the wall painting (photo by the author).

The biggest problem was the curvature of the surfaces of the conserved units, because each unit had to be glued together separately. After that, a decorative plaster was applied and, finally, a *tratteggio* retouching technique was used, which visually mutually connected the installed units. In order to gain a better comprehension of the iconography, a painted reconstruction of the painting was done as well (Rogić 2018: 899, fig 2).

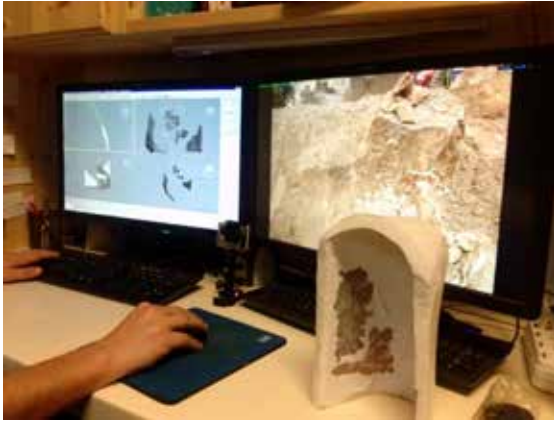
Figure 6b. Construction 2 - Photogrammetry process (photo by the author).

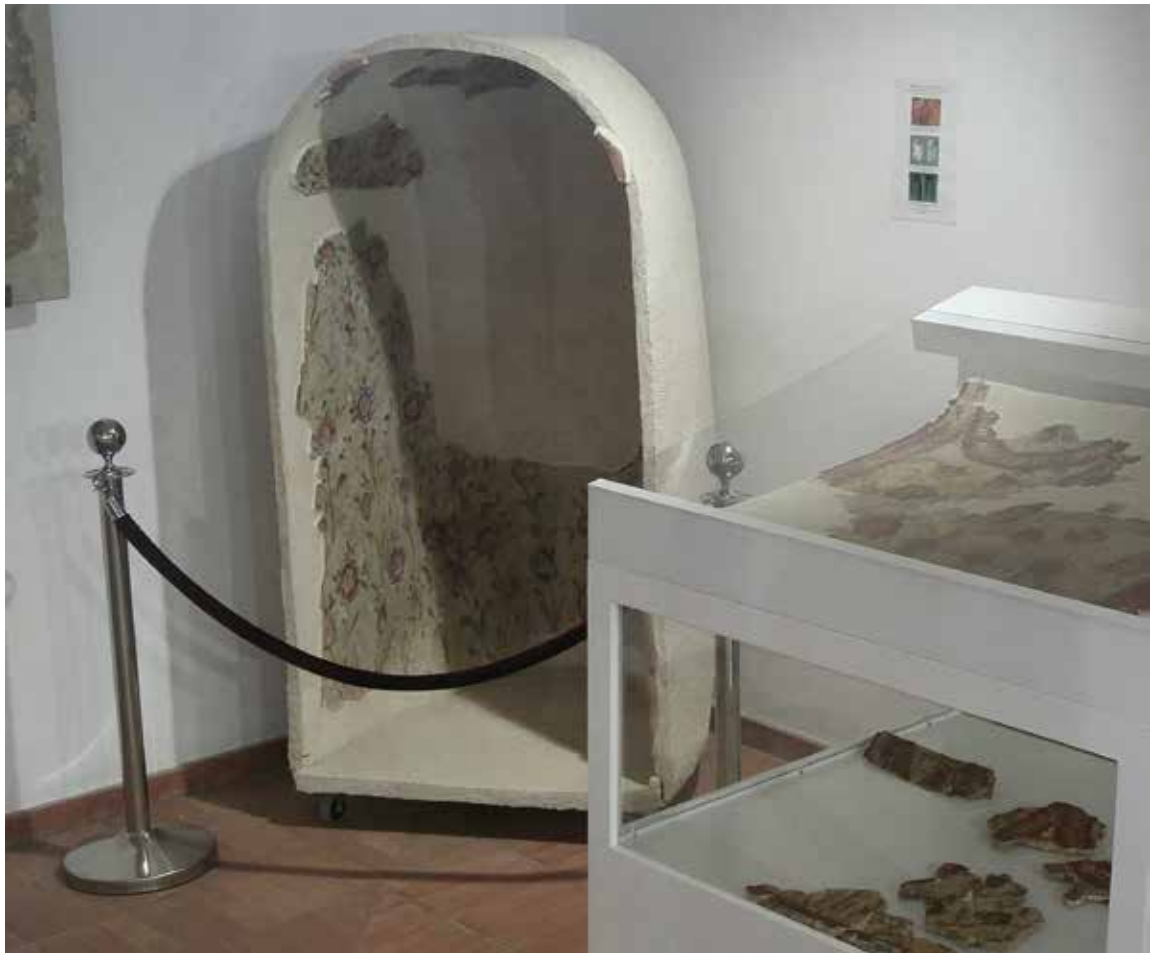
Figure 6c. Construction 2 - Reconstruction of Construction 2 with the fragments of the original wall painting (photo by the author).

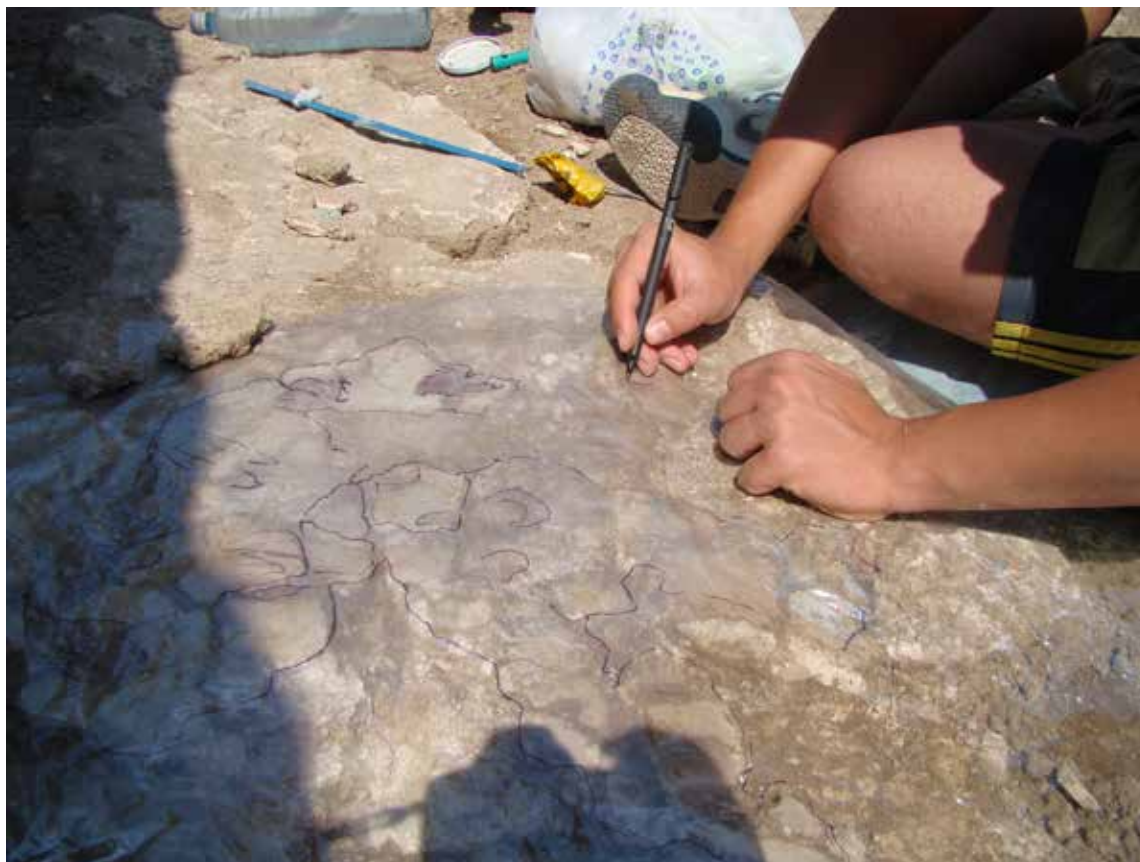
Figure 7a. Amphitheatre arena wall - Drawing the layout of the fragments *in situ* near the arena wall (photo by the author).

The largest part of the work was the extraction of these fragments from the ground, which was done by conservators from the Institute of Archaeology, after which they worked on the classification of materials by colour and type of rendering, consolidation of the fragments and joining them together into units as much as the available material allowed (**Figure 7b**).

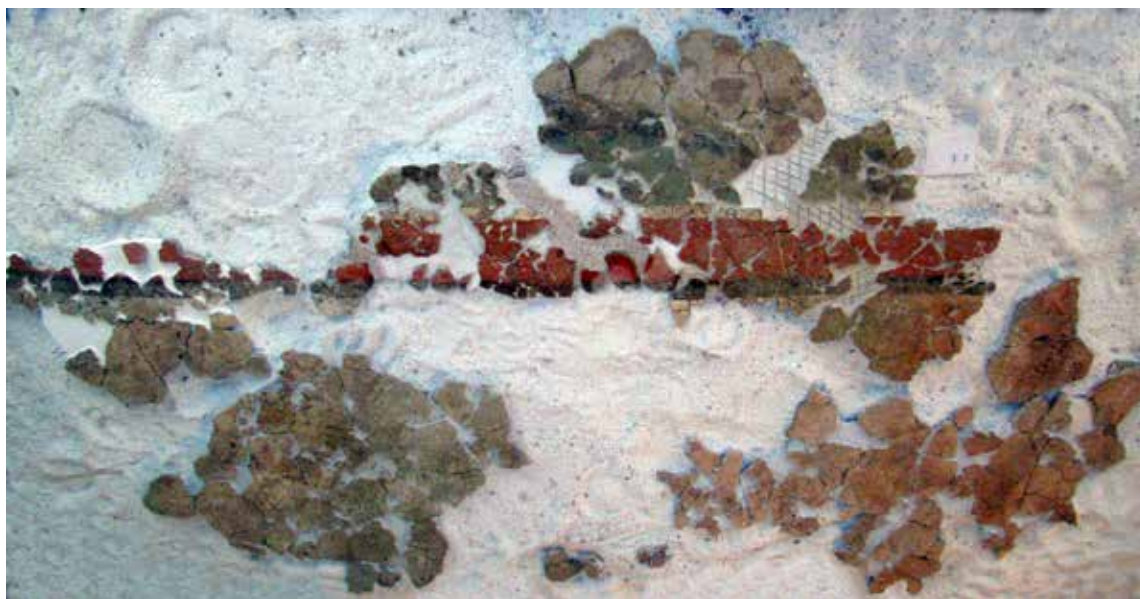
Figure 7b. Amphitheatre arena wall - Joined fragments of one of the painting units from the arena wall (photo by the author).

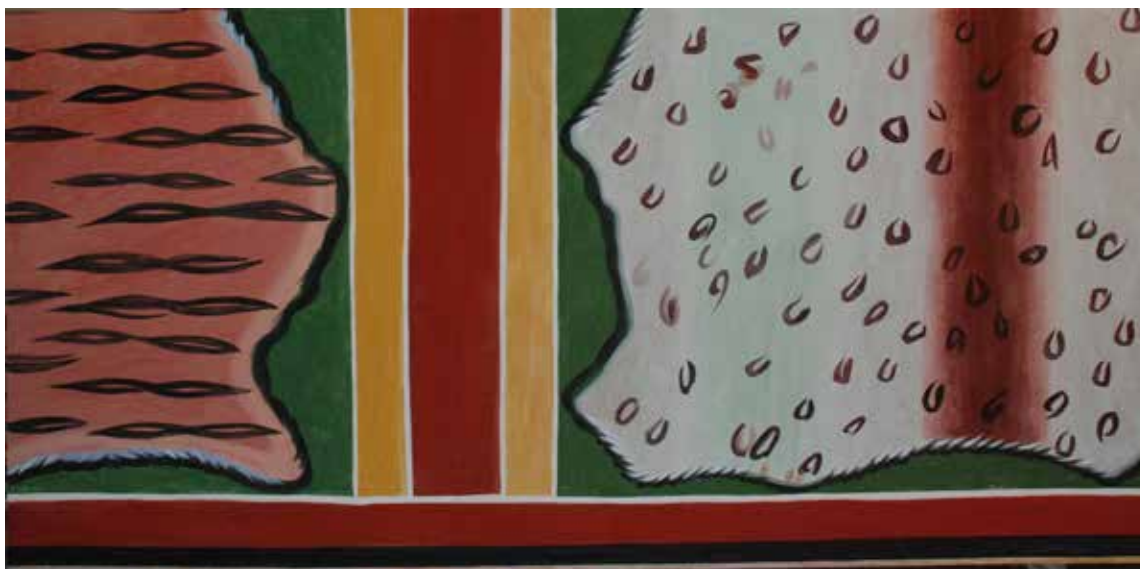
Figure 7c. Amphitheatre arena wall - Painted hypothetical reconstruction of the part of the painted decoration from the arena wall, made on the basis of the original painting (after: Рогић 2014a: 153, fig. 11; and Bogdanović, Rogić and Vuković-Bogdanović 2018: 46, fig. 3).

rendering, which at the same time had no special visual characteristics, it was decided to level the back of the joined units with the use of a grinder. The units obtained (nine units have so far been made, and a separate publication about them is being prepared) were transferred onto aluminium honeycomb panels. Edging repairs, decorative rendering and retouching were carried out and the *tratteggio* retouching technique was applied, with conservation lasting from 2013 to 2015 (Рогић 2014a: 148–154; Rogić 2017: 153, 156–157). Additionally, part of the hypothetical painted reconstruction of the arena wall painting was completed (Рогић 2014a:153; Bogdanović, Rogić and Vuković-Bogdanović 2018: 46) (**Figure 7c**).

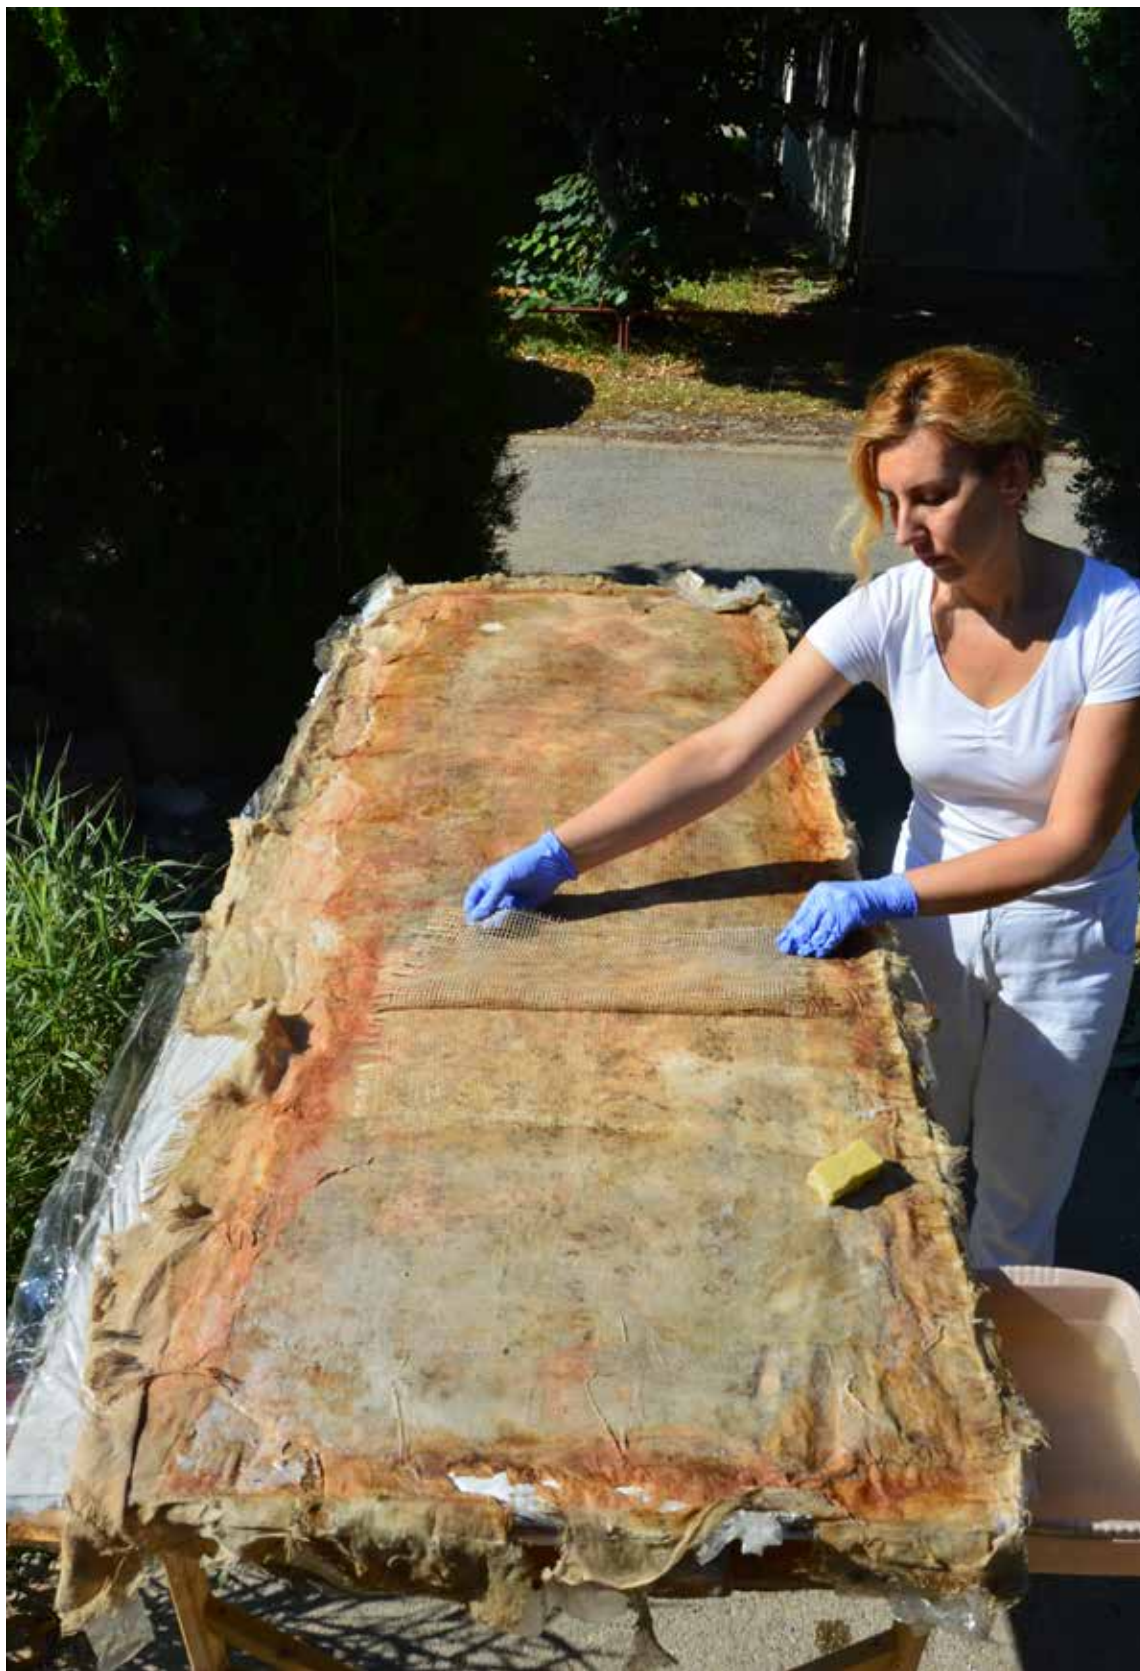
Figure 8a. Grave G-3130 - Removal of old facing (photographic documentation of the Institute of Archaeology).

Conservation works in 2017 were started by removing the bricks from the back of the wall paintings, with which they were transferred in 1983. After consolidation and levelling of the plaster, i.e., its thinning, a reinforced polyester support was made and applied to the already conserved units. Also, a similar decorative plaster was chosen, whose grey, neutral colour highlighted the painted content. A standard retouch was performed.

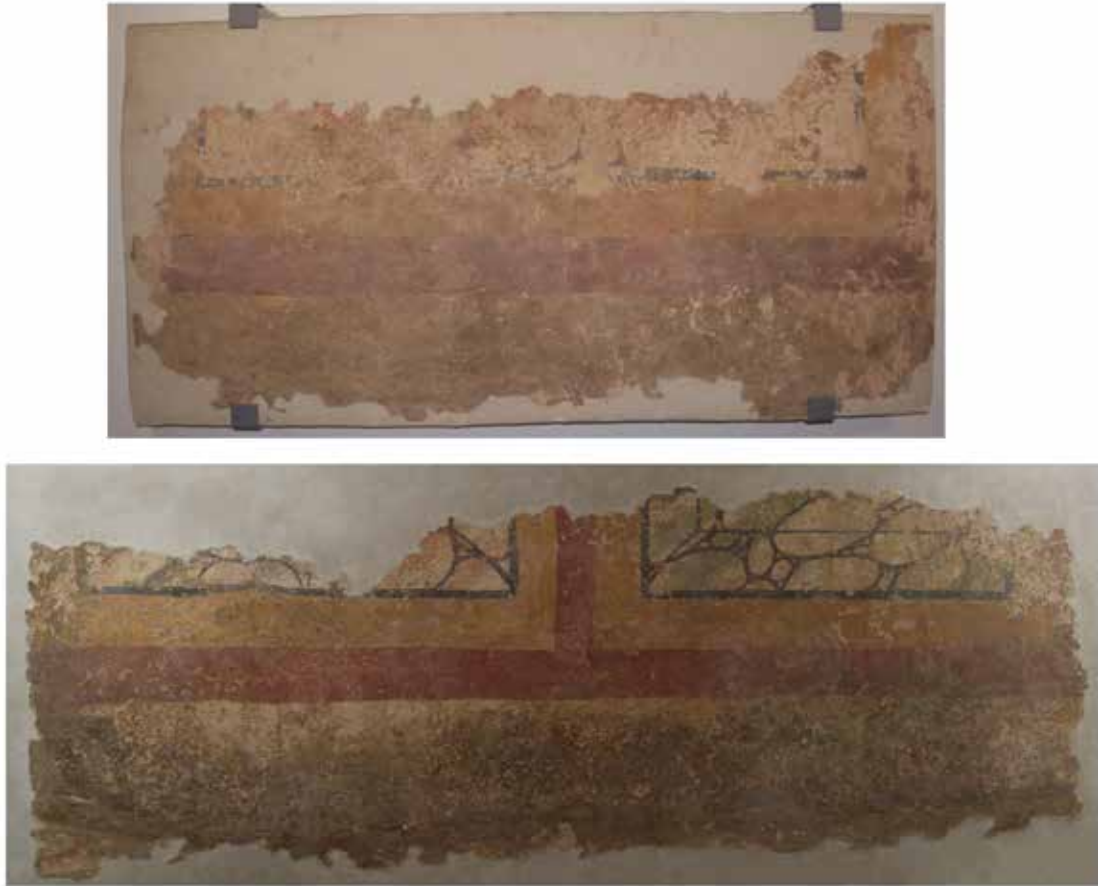
Figure 8b. Grave G-3130 - Eastern longitudinal and southern front side of the grave after conservation (after: Rogić 2018a: 173, fig. 6, 180, fig. 15).

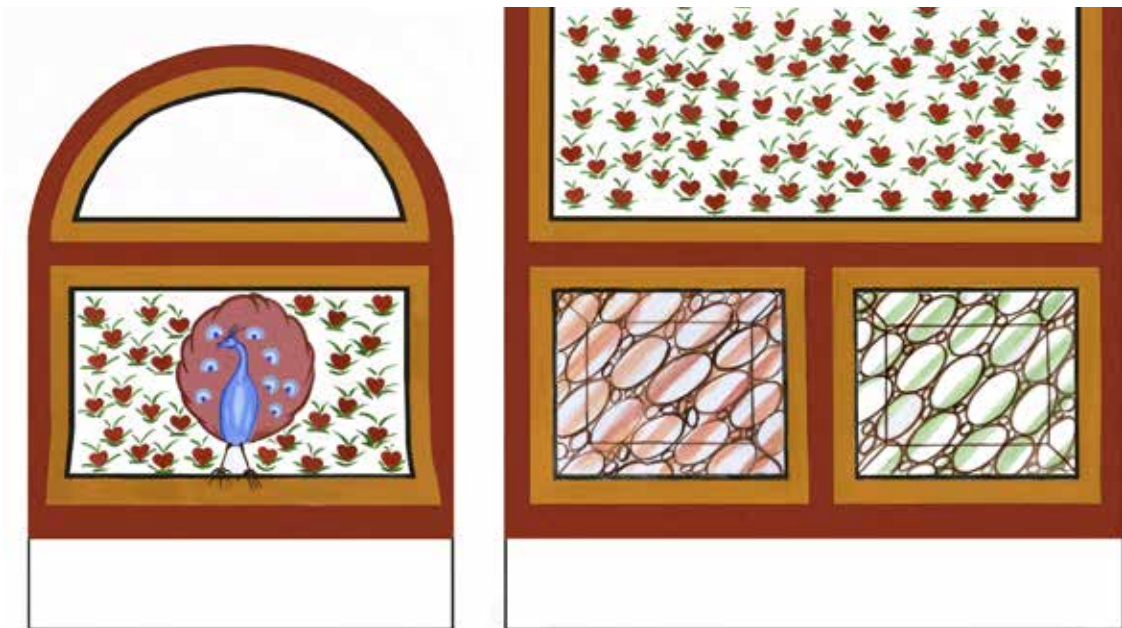
Figure 8c. Grave G-3130 - Painted hypothetical reconstruction of the painting (after: Rogić 2018a: fig 23, 188).

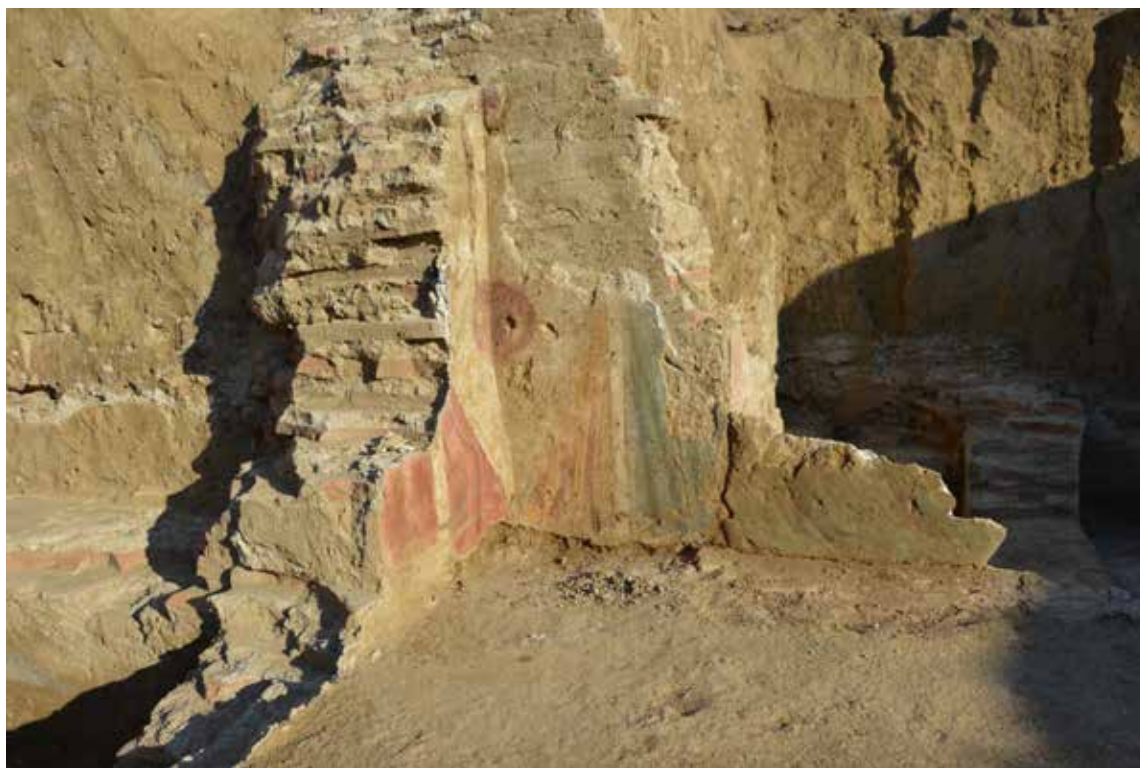
Figure 9a. *Memoria* - Wall painting in the corner of the central room (photo by the author).

Memoria. During the archaeological excavations for the construction of a new industrial facility within the thermal power plant Kostolac B in the village of Drmno, carried out in 2016, a tomb was found, the so-called *memoria*, with the remains of a wall painting *in situ* (Figures 9a and 9b), dated to the middle of the 4th century (Redžić *et al.* 2018: 85–86; Vojvoda, Redžić 2020: 225). On the remains of wall paintings, imitation of stone panels can be recognised (Figure 9c).

Unfortunately, the tomb had to be relocated, given its position. This meant detaching the paintings from the walls beforehand. First, the wall paintings were cleaned (Figure 9b) in order to determine their state of preservation and then they were protected with facings. The paintings were protected with rigid supports - solid wooden structures, after which they were removed. The wall was cut from the back, the bricks were gradually separated to the plaster of the wall painting, and the paintings were transferred to the conservation studio. Then, work was carried out on the stabilisation of the plaster, so the creation of polyester

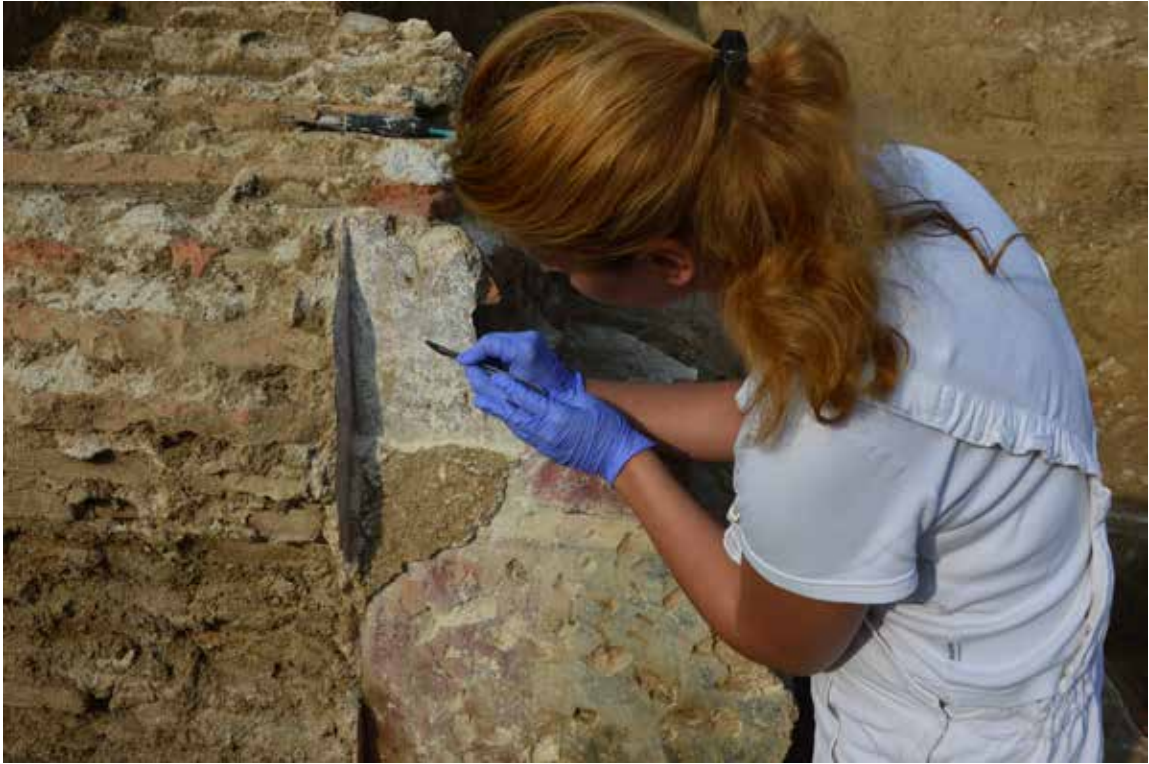
Figure 9b. *Memoria* - Cleaning of the painting layer *in situ* (photographic documentation of the Institute of Archaeology).

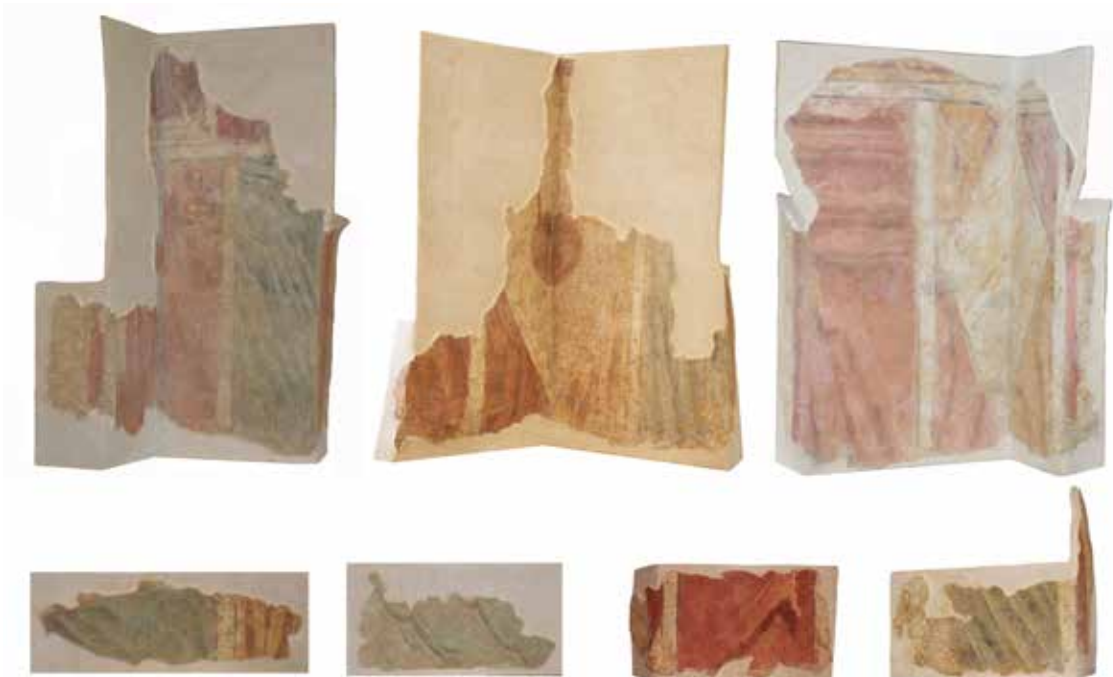
Figure 9c. *Memoria* - Conserved and restored wall paintings (photo by the author).

supports was initiated. Edging repair was done and, after drying, decorative plaster was applied, the lacunas were filled, and retouching was carried out (Redžić *et al.* 2018: 86). The conservation process was carried out in 2017. After the conservation, the wall paintings were displayed on the walls of the Viminacium Museum (Figure 9c).

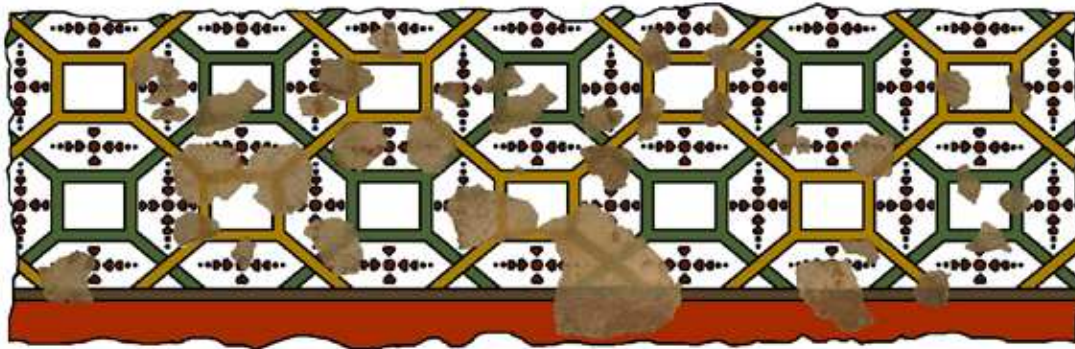
Figure 10. Hypothetical reconstruction of the painting scheme from the structure of the Nad Klepečkom site (after: Рогић и Марковић 2010: 181, fig. 4).
