PRESERVING THE DANUBE LIMES IN SERBIA: A REVIEW OF THE BIODETERIORATION OF TRAJAN'S BRIDGE*

Abstract. – One of the most significant monuments of the Roman Danube Limes is Trajan's Bridge, built in the period from 103 to 105 AD. The remains of the pillars on the Serbian bank of the Danube were partially restored four decades ago. Today, the pillar that is closest to the river, which has not undergone conservation, is subject to different types of deterioration. During the comparison between the present condition of the pillar and those recorded in photos over the last six decades, we can estimate that its level of material loss has not overly changed. However, the difference in biological growth is visible. The primary aim of this study was to record the degree of infestation and endangerment of the monument and check for possible risks of mortar deterioration where mortar is in direct contact with severely infested bricks. Moreover, a characterisation of the biodeteriogens was performed. Special emphasis was given to fungi as the main agents of deterioration. A precise assessment of the level of risk they pose to this monument was made as a basis for the formulation and implementa

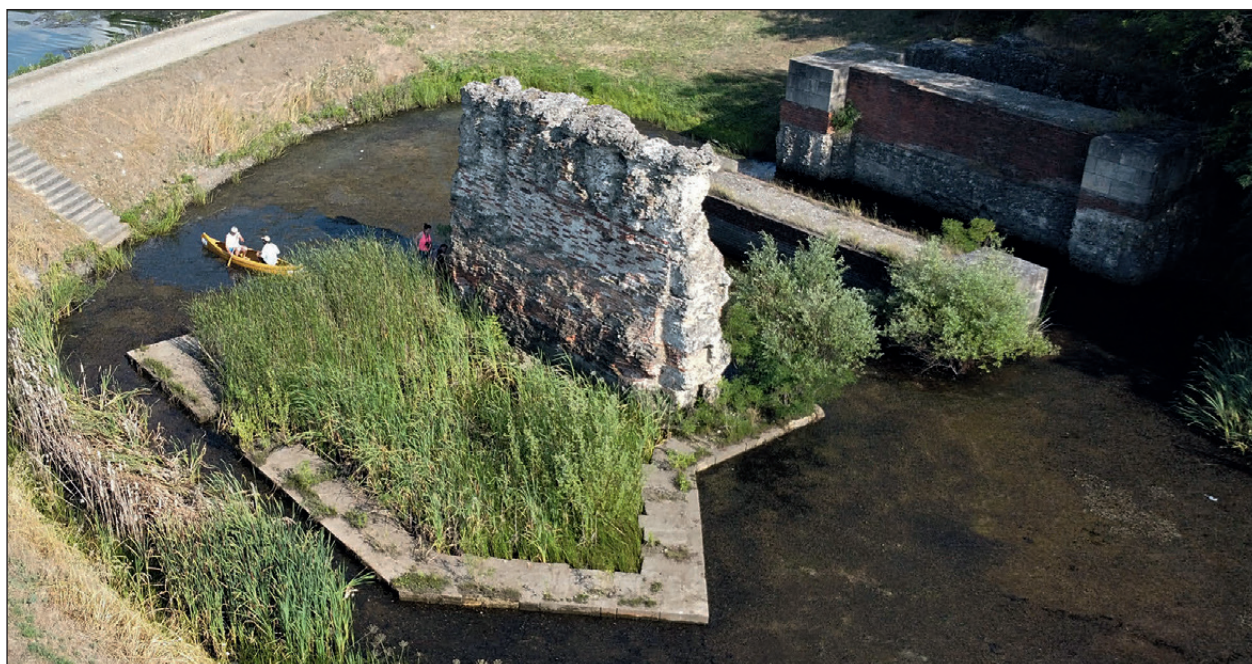
Fig. 1. View from the northwest to the remains of Trajan's Bridge on the Serbian bank of the Danube in July 2021 (Archive of the Institute of Archaeology, Belgrade)

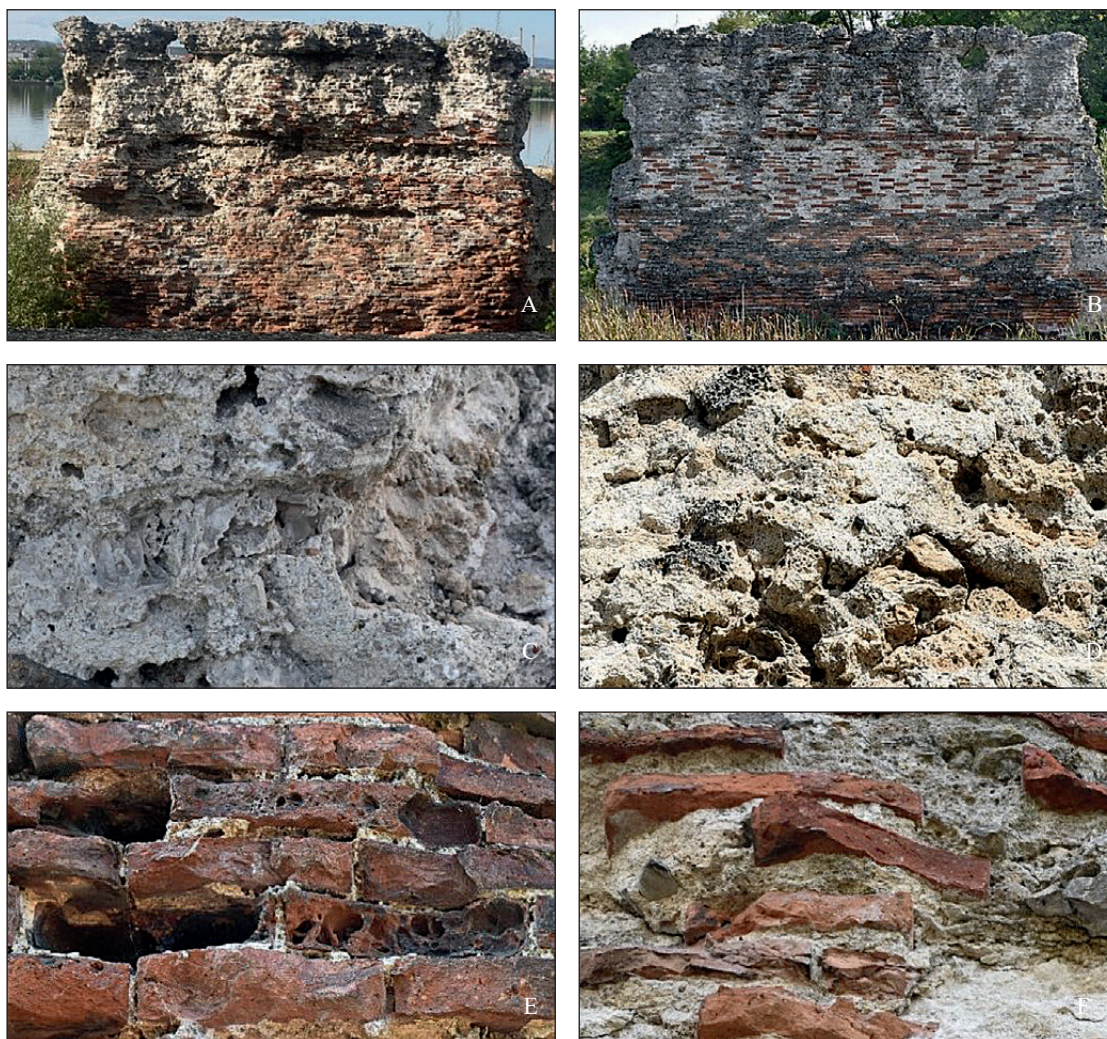
however, for parts that are always above the water and for those whose submergence depends on the variations in the level of the Danube. Most of the bricks are in a state of spalling and erosion, and the alveolisation of a number of bricks with occasional cracking is also noticeable, as well as the formation of deposits, with pronounced discolouration in the lowest zone. As for the porous stone in the core of the pillar, the most pronounced deterioration is alveolisation with erosion, but there is also scaling and delamination of the stone blocks of the restored platform, which is mostly in water. The mortar is the least affected by these changes, but alveolisation with erosion can be observed as well. The northern side of the pillar has the highest level of deterioration of materials (Fig. 5).

Fig. 5. Deterioration of the pillar – southern side in 2020 (A), and northern side in 2022 (B); stone and mortar deterioration in 2020 (C, D); brick and mortar deterioration in 2021 (E), and in 2022 (F) (Archive of the MoDeCo2000 project)

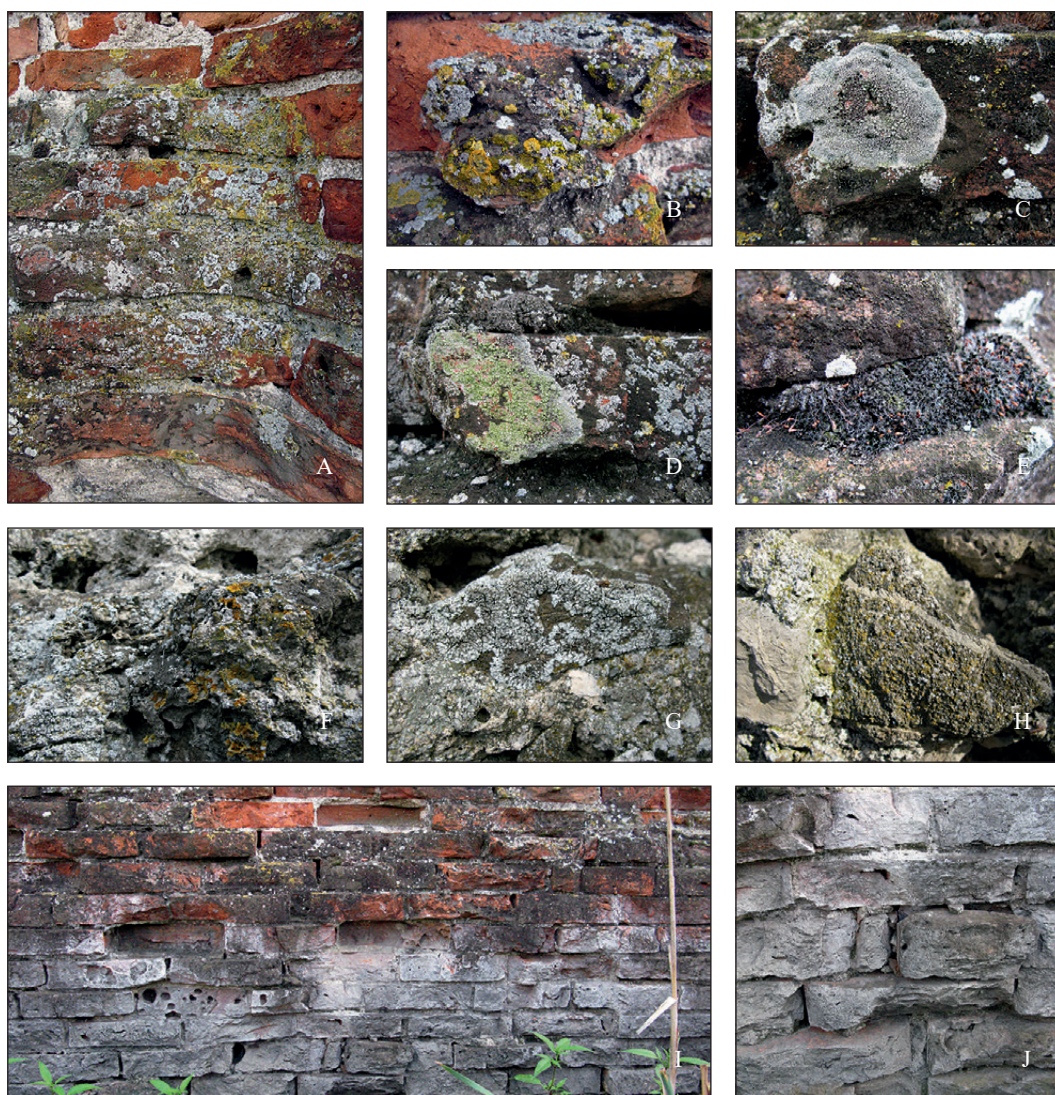
Severe macrofouling in the form of lichen infestation of brick (Fig. 6A–D) and stone (Fig. 6F–H) was documented both visually and in more detail via *in situ* microscopy (Fig. 7). On the basis of the visual observation alone, a gradient of colonisation, in terms of substrate bioreceptivity, could be established, with

Fig. 6. Lichen and moss infestation of brick (A–D), mortar (E), and stone (F–H) of the pillar in September, 2022; lower, usually submerged part is discoloured and infestation free (I–J) (Archive of the PROTECTA project)
